# Access Compliance Report Public Rights-of-Way (Pedestrian Signals)

Main Street: COW\_CAMP\_RD Cross Street: ESENCIA\_DR Location: N

ADA ID: SGRK211129120731 Signal Type: One Push Button-Non APS Overall Compliance: No Severity Scores: BTN 1: 25 BTN 2: N/A No BTN: N/A

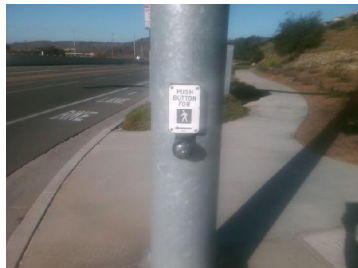
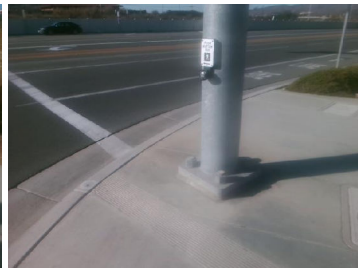
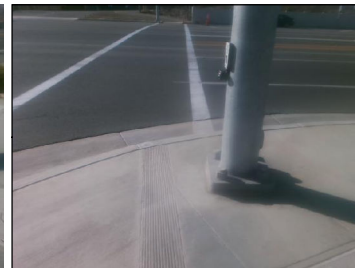
| Compliance | Description | Data | Compliance | Description | Data |
|---|---|---|---|---|---|
| No B 1 Clear Floor Space Slope (%) | 6.3 | N/A | N/A | B 2 Clear Floor Space XSlope (%) | N/A |
| No B 1 Clear Floor Space XSlope (%) | 3.6 | N/A | N/A | B 2 PAR Slope (%) | N/A |

Possible Solutions: Remove and Replace Clear Space.
