# Access Compliance Report Public Rights-of-Way (Pedestrian Signals)

Main Street: **ESENCIA\_DR** Cross Street: **COW\_CAMP\_RD** Location: **E**

ADA ID: **SGRK211129121527** Signal Type: **One Push Button-Non APS** Overall Compliance: **No** Severity Scores: **BTN 1: 25** **BTN 2: N/A** **No BTN: N/A**

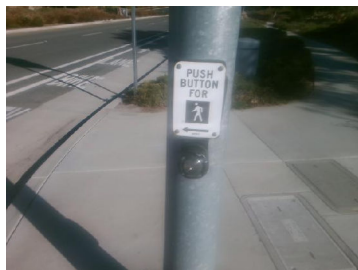
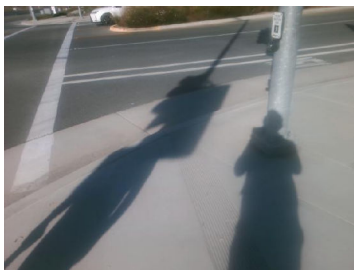
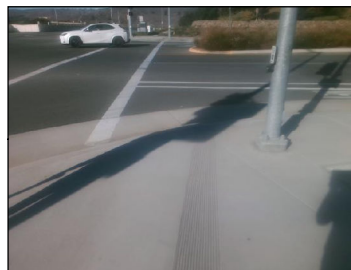
| Compliance | Description | Data | Compliance | Description | Data |
|---|---|---|---|---|---|
| <b>No</b> | B 1 Clear Floor Space Slope (%) | <b>3.1</b> | <b>N/A</b> | B 2 Clear Floor Space Slope (%) | <b>N/A</b> |
| <b>No</b> | B 1 Clear Floor Space XSlope (%) | <b>3.2</b> | <b>N/A</b> | B 2 Clear Floor Space XSlope (%) | <b>N/A</b> |
| <b>No</b> | B 1 DistanceTo XWalk (in) | <b>101</b> | <b>N/A</b> | B 2 DistanceTo XWalk (in) | <b>N/A</b> |

**Possible Solutions: Replace Signal Push Button With APS Button. Remove & Relocate Sign.**

Total Cost: \$ **650**
