# Access Compliance Report Public Rights-of-Way (Pedestrian Signals)

Main Street: COW\_CAMP\_RD Cross Street: LOS\_PATRONES\_PKWY Location: N

ADA ID: SGRK211130113720 Signal Type: One Push Button-APS Overall Compliance: No Severity Scores: BTN 1: 25 BTN 2: N/A No BTN: N/A

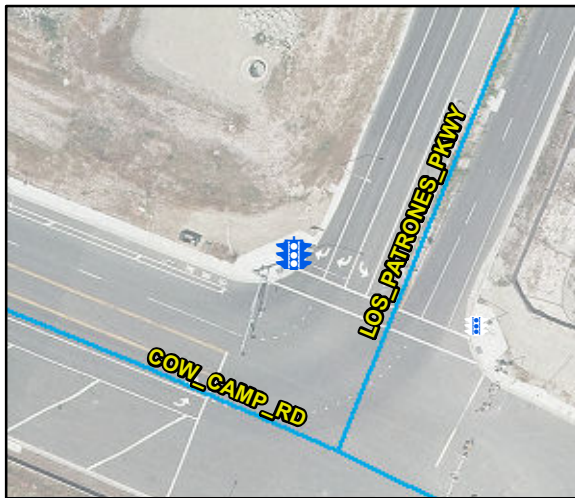
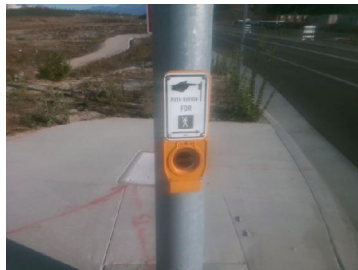
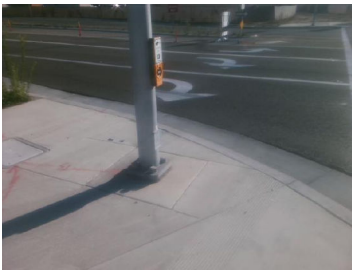
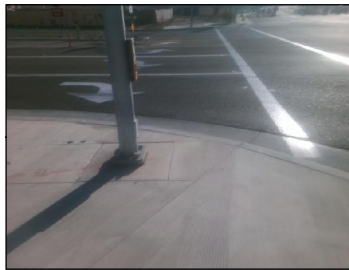
| Compliance | Description | Data | Compliance | Description | Data |
|---|---|---|---|---|---|
| No | B 1 Clear Floor Space XSlope (%) | 4.1 | N/A | B 2 Clear Floor Space XSlope (%) | N/A |
| No | B 1 DistanceTo XWalk (in) | 72 | N/A | B 2 DistanceTo XWalk (in) | N/A |

Possible Solutions: Replace Signal Push Button With APS Button. Remove & Relocate Sign.

OC Std/PROW: MUTCD 4e.08, R404.2
