# Access Compliance Report Public Rights-of-Way (Pedestrian Signals)

Main Street: CHIQUITA\_CANYON\_DR Cross Street: CHIQUITA\_CANYON\_DR Location: S

ADA ID: SGRK211130120515 Signal Type: One Push Button-APS Overall Compliance: No Severity Scores: BTN 1: 0 BTN 2: N/A No BTN: N/A

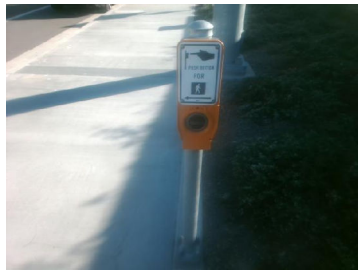
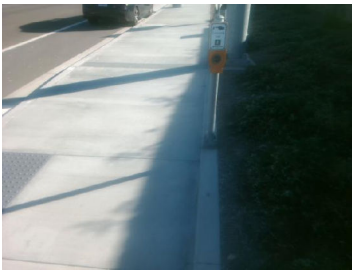
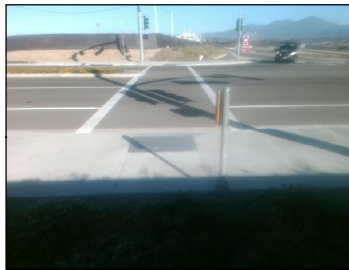
| Compliance | Description | Data | Compliance | Description | Data |
|---|---|---|---|---|---|
| No | B 1 DistanceTo Curb (in) | 104 | N/A | B 2 DistanceTo Curb (in) | N/A |

Possible Solutions: Replace Signal Push Button With APS Button. Remove & Relocate Sign.
