# Access Compliance Report Public Rights-of-Way (Pedestrian Signals)

Main Street: AIROSO\_ST Cross Street: CHIQUITA\_CANYON\_DR Location: NE

ADA ID: SGRK211130123844 Signal Type: One Push Button-Non APS Overall Compliance: No Severity Scores: BTN 1: 35 BTN 2: N/A No BTN: N/A

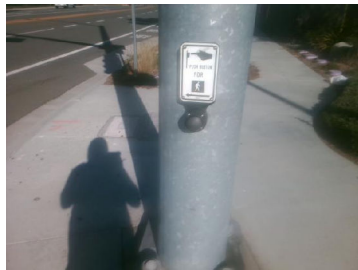
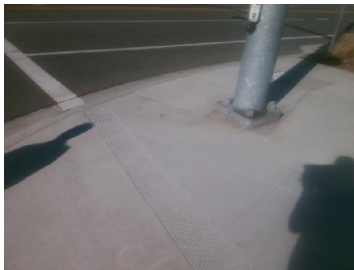
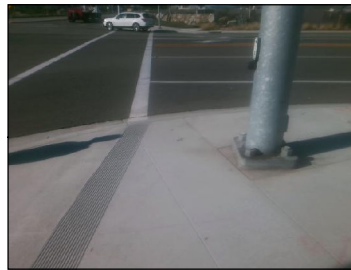
| No B 1 Pilot Light? | No | N/A B 2 Pilot Light? | N/A |

| Compliance | Description | Data | Compliance | Description | Data |
|---|---|---|---|---|---|
| No B 1 Clear Floor Space Slope (%) | 4.4 | N/A | B 2 Clear Floor Space Slope (%) | N/A | |
| No B 1 Clear Floor Space XSlope (%) | 2.8 | N/A | B 2 Clear Floor Space XSlope (%) | N/A | |
| No B 1 DistanceTo XWalk (in) | 65 | N/A | B 2 DistanceTo XWalk (in) | N/A | |

Possible Solutions: Replace Signal Push Button With APS Button. Remove & Relocate Sign.
