# Access Compliance Report Public Rights-of-Way (Pedestrian Signals)

Main Street: AIROSO\_ST Cross Street: CHIQUITA\_CANYON\_DR Location: NE

ADA ID: SGRK211130123952 Signal Type: One Push Button-Non APS Overall Compliance: No Severity Scores: BTN 1: 10 BTN 2: N/A No BTN: N/A

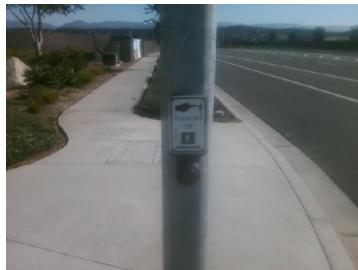
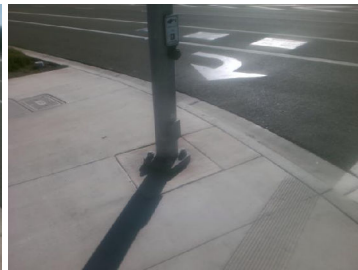
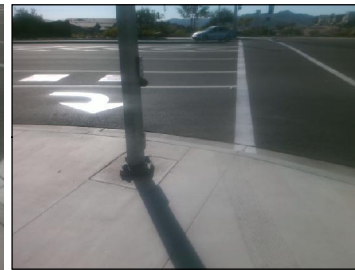
| No B 1 Pilot Light? | No | N/A B 2 Pilot Light? | N/A |

Possible Solutions: Replace Signal Push Button With APS Button.

OC Std/PROW: MUTCD 4e.08

Total Cost: \$ 900
