# Access Compliance Report Public Rights-of-Way (Pedestrian Signals)

Main Street: **CHIQUITA\_CANYON\_DR** Cross Street: **AIROSO\_ST** Location: **SE**

ADA ID: **SGRK211130124519** Signal Type: **One Push Button-Non APS** Overall Compliance: **No** Severity Scores: **BTN 1: 35** **BTN 2: N/A** **No BTN: N/A**

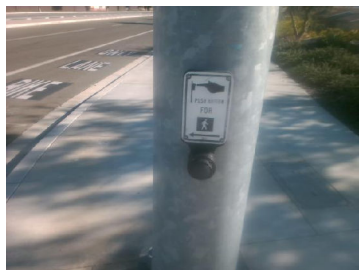
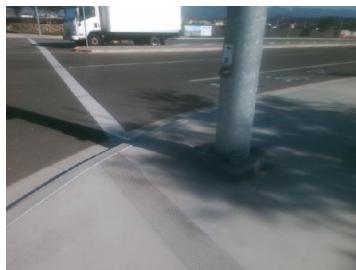
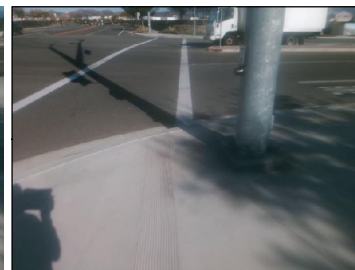
| <b>No</b> B 1 Pilot Light? | <b>No</b> | <b>N/A</b> B 2 Pilot Light? | <b>N/A</b> |

| Compliance | Description | Data | Compliance | Description | Data |
|---|---|---|---|---|---|
| <b>No</b> | B 1 Clear Floor Space XSlope (%) | <b>2.3</b> | <b>N/A</b> | B 2 Clear Floor Space XSlope (%) | <b>N/A</b> |

Possible Solutions: Replace Signal Push Button With APS Button. Remove and Replace Clear Space.
