# Access Compliance Report Public Rights-of-Way (Pedestrian Signals)

Main Street: AIROSO\_ST Cross Street: CHIQUITA\_CANYON\_DR Location: SW

ADA ID: SGRK211130125116 Signal Type: One Push Button-Non APS Overall Compliance: No Severity Scores: BTN 1: 35 BTN 2: N/A No BTN: N/A

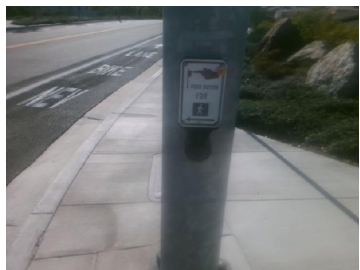
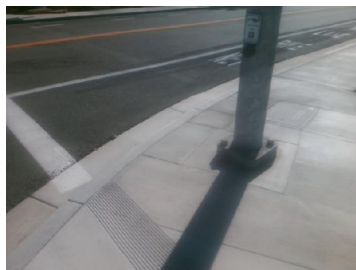
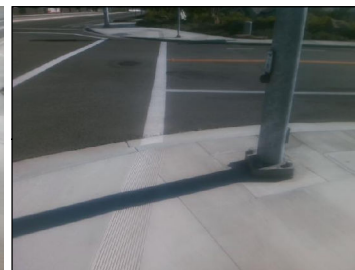
| Compliance | Description | Data | Compliance | Description | Data |
|---|---|---|---|---|---|
| No B 1 Clear Floor Space Slope (%) | 3.8 | N/A | B 2 Clear Floor Space Slope (%) | N/A | |
| No B 1 Clear Floor Space XSlope (%) | 3.4 | N/A | B 2 Clear Floor Space XSlope (%) | N/A | |

Possible Solutions: Replace Signal Push Button With APS Button. Remove and Replace Clear Space.
