# Access Compliance Report Public Rights-of-Way (Pedestrian Signals)

Main Street: AIROSO\_ST Cross Street: CHIQUITA\_CANYON\_DR Location: SW

ADA ID: SGRK211130125239 Signal Type: One Push Button-Non APS Overall Compliance: No Severity Scores: BTN 1: 35 BTN 2: N/A No BTN: N/A

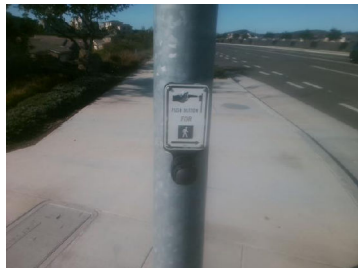
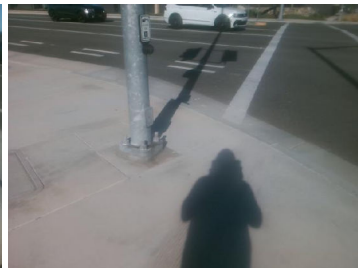
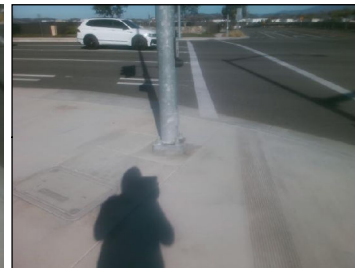
| No B 1 Pilot Light? | No | N/A B 2 Pilot Light? | N/A |

| Compliance | Description | Data | Compliance | Description | Data |
|---|---|---|---|---|---|
| No B 1 Clear Floor Space Slope (%) | 3.6 | N/A | B 2 Clear Floor Space Slope (%) | N/A | |

Possible Solutions: Replace Signal Push Button With APS Button. Remove and Replace Clear Space.

OC Std/PROW: R404.2, R404.3, MUTCD 4e.08
