# Access Compliance Report Public Rights-of-Way (Pedestrian Signals)

Main Street: **CHIQUITA\_CANYON\_DR** Cross Street: **AIROSO\_ST** Location: **NW**

ADA ID: **SGRK211130125658** Signal Type: **One Push Button-Non APS** Overall Compliance: **No** Severity Scores: **BTN 1: 10 BTN 2: N/A No BTN: N/A**

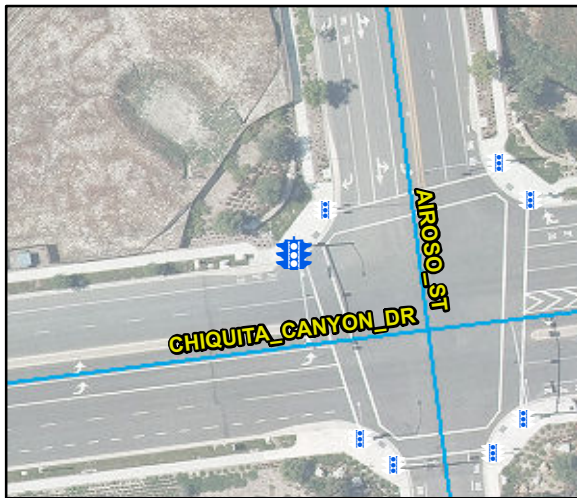
| <b>No</b> B 1 Pilot Light? | <b>No</b> | <b>N/A</b> B 2 Pilot Light? | <b>N/A</b> |

Possible Solutions: Replace Signal Push Button With APS Button.

OC Std/PROW: **MUTCD 4e.08**

Total Cost: \$ **900**
