# Access Compliance Report Public Rights-of-Way (Pedestrian Signals)

Main Street: **ANTONIO\_PKWY** Cross Street: **N/A** Location: **SW**

ADA ID: **SGRK211202125904** Signal Type: **One Push Button-Non APS** Overall Compliance: **No** Severity Scores: **BTN 1: 10** **BTN 2: N/A** **No BTN: N/A**

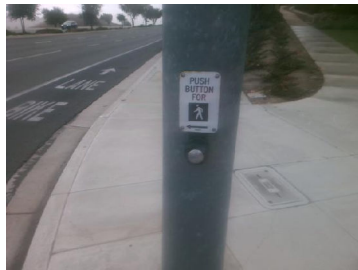
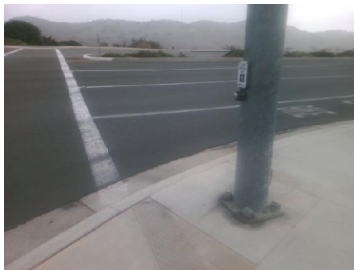
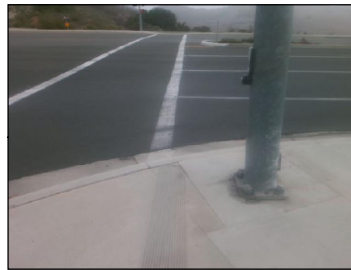
| <b>No</b> B 1 Pilot Light? | <b>No</b> | <b>N/A</b> B 2 Pilot Light? | <b>N/A</b> |

**Possible Solutions: Replace Signal Push Button With APS Button.**

**OC Std/PROW: MUTCD 4e.08**

Total Cost: \$ **900**
