# Access Compliance Report Public Rights-of-Way (Pedestrian Signals)

Main Street: ANTONIO\_PKWY Cross Street: N/A Location: SW

ADA ID: SGRK211202130509 Signal Type: One Push Button-Non APS Overall Compliance: No Severity Scores: BTN 1: 10 BTN 2: N/A No BTN: N/A

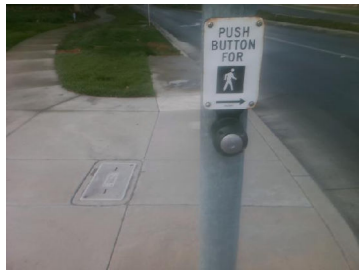
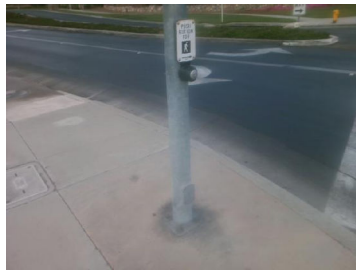
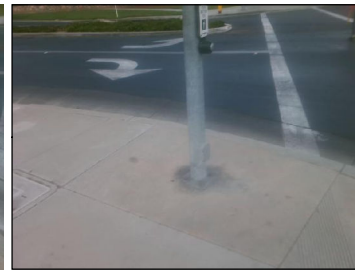
| No B 1 Pilot Light? | No | N/A B 2 Pilot Light? | N/A |

Possible Solutions: Replace Signal Push Button With APS Button.

Total Cost: \$ 900
