# Access Compliance Report Public Rights-of-Way (Pedestrian Signals)

Main Street: SEAL\_BEACH\_BLVD Cross Street: ST\_CLOUD\_DR Location: NE

ADA ID: SGRK211206155347 Signal Type: One Push Button-Non APS Overall Compliance: No Severity Scores: BTN 1: 10 BTN 2: N/A No BTN: N/A

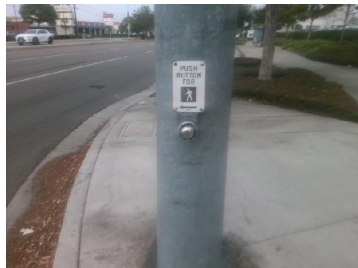
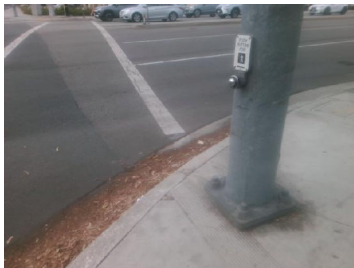
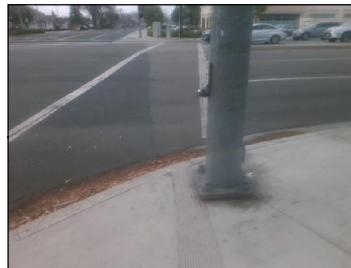
| N/A Is Button 1 APS or Non-APS? | NonAPS | N/A Is Button 2 APS or Non-APS? | N/A |
| No B 1 VibroTact Parallel to Xing? | N/A | N/A B 2 VibroTact Parallel to Xing? | N/A |
| N/A B 1 Pilot Light Illumination? | No | N/A B 2 Pilot Light Illumination? | N/A |

Possible Solutions: Replace Signal Push Button With APS Button.

OC Std/PROW: MUTCD 4e.08

Total Cost: \$ 900
