# Access Compliance Report Public Rights-of-Way (Pedestrian Signals)

Main Street: **LOS ALAMITOS BLVD** Cross Street: **ORANGEWOOD AVE** Location: **SW**

ADA ID: **SGRK211217115019** Signal Type: **One Push Button-Non APS** Overall Compliance: **No** Severity Scores: **BTN 1: 35** **BTN 2: N/A** **No BTN: N/A**

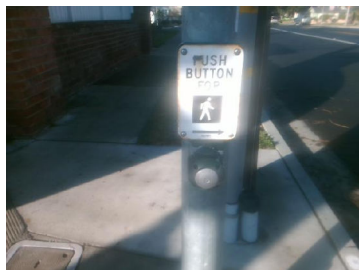
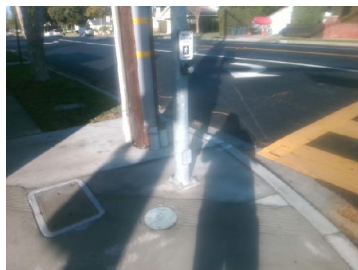
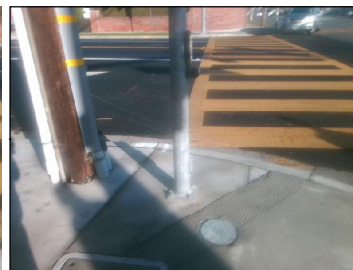
| <b>No</b> B 1 Pilot Light? | <b>No</b> | <b>N/A</b> B 2 Pilot Light? | <b>N/A</b> |

| Compliance | Description | Data | Compliance | Description | Data |
|---|---|---|---|---|---|
| <b>No</b> | B 1 Clear Floor Space Slope (%) | <b>3.7</b> | <b>N/A</b> | B 2 Clear Floor Space Slope (%) | <b>N/A</b> |

**Possible Solutions: Replace Signal Push Button With APS Button. Remove and Replace Clear Space.**

**OC Std/PROW: R404.2, R404.3, MUTCD 4e.08**
