# Access Compliance Report Public Rights-of-Way (Pedestrian Signals)

Main Street: ORANGEWOOD\_AVE Cross Street: LOS\_ALAMITOS\_BLV Location: SE

ADA ID: SGRK211217115807 Signal Type: One Push Button-Non APS Overall Compliance: No Severity Scores: BTN 1: 10 BTN 2: N/A No BTN: N/A

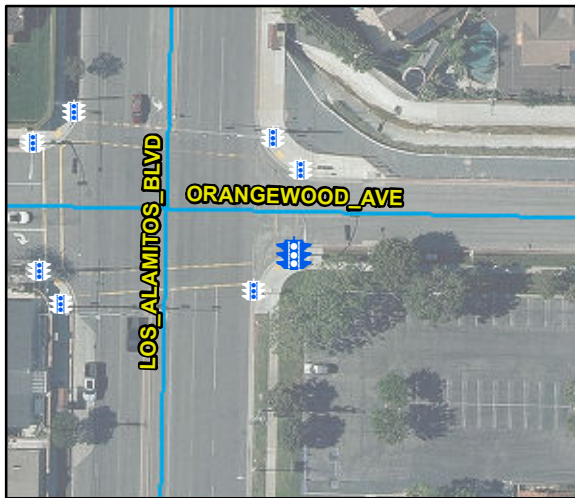
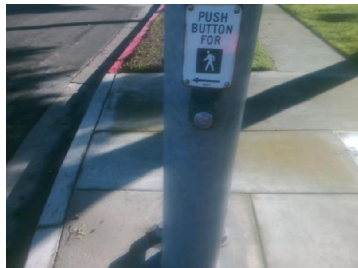
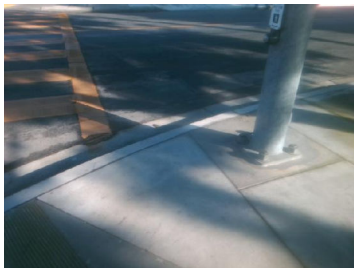
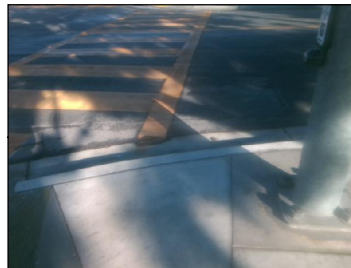
| No B 1 Pilot Light? | No | N/A B 2 Pilot Light? | N/A |

Possible Solutions: Replace Signal Push Button With APS Button.

Total Cost: \$ 900
