# Access Compliance Report Public Rights-of-Way (Pedestrian Signals)

Main Street: ORANGEWOOD\_AVE Cross Street: LOS\_ALAMITOS\_BLV Location: NW

ADA ID: SGRK211217120852 Signal Type: One Push Button-Non APS Overall Compliance: No Severity Scores: BTN 1: 35 BTN 2: N/A No BTN: N/A

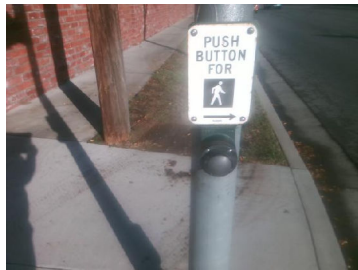
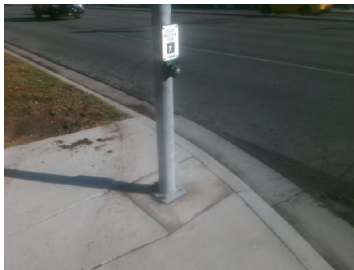
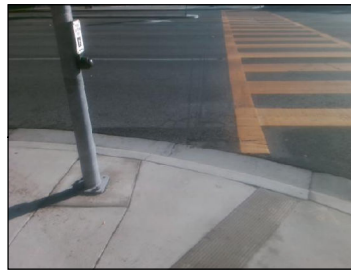
| No B 1 Pilot Light? | No | N/A B 2 Pilot Light? | N/A |

| Compliance | Description | Data | Compliance | Description | Data |
|---|---|---|---|---|---|
| No B 1 Clear Floor Space Slope (%) | | 6.4 | N/A | B 2 Clear Floor Space Slope (%) | N/A |
| Yes B 1 Clear Floor Space XSlope (%) | | 1.8 | N/A | B 2 Clear Floor Space XSlope (%) | N/A |

Possible Solutions: Replace Signal Push Button With APS Button. Remove and Replace Clear Space.
