# Access Compliance Report Public Rights-of-Way (Pedestrian Signals)

Main Street: **ROSSMOOR\_WAY** Cross Street: **LOS\_ALAMITOS\_BVD** Location: **SE**

ADA ID: **SGRK211217130436** Signal Type: **One Push Button-Non APS** Overall Compliance: **No** Severity Scores: **BTN 1: 10** **BTN 2: N/A** **No BTN: N/A**

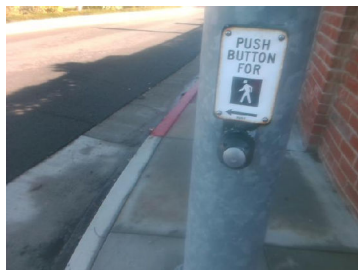
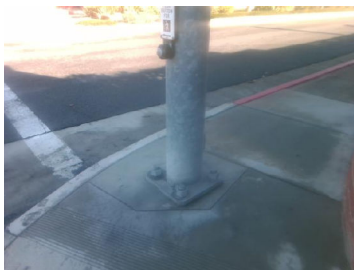
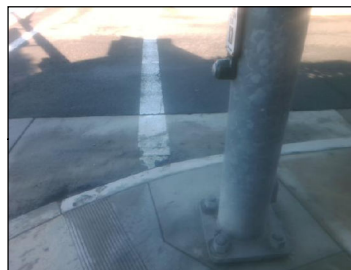
| <b>No</b> B 1 Pilot Light? | <b>No</b> | <b>N/A</b> B 2 Pilot Light? | <b>N/A</b> |

Possible Solutions: Replace Signal Push Button With APS Button.

OC Std/PROW: **MUTCD 4e.08**

Total Cost: \$ **900**
