# Access Compliance Report Public Rights-of-Way (Pedestrian Signals)

Main Street: SEAL\_BEACH\_BLVD Cross Street: BRADBURY\_RD Location: SW

ADA ID: SGRK211221111843 Signal Type: One Push Button-Non APS Overall Compliance: No Severity Scores: BTN 1: 35 BTN 2: N/A No BTN: N/A

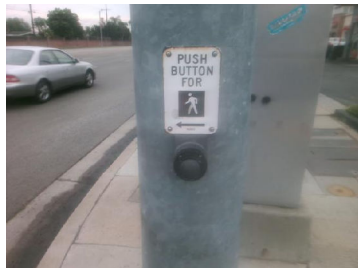
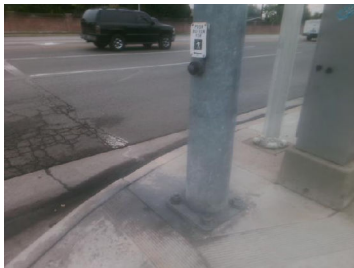
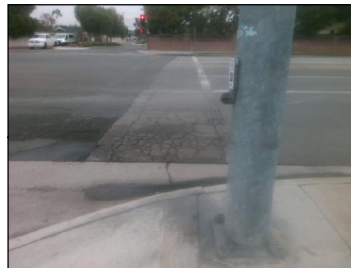
| Compliance | Description | Data | Compliance | Description | Data |
|---|---|---|---|---|---|
| No B 1 Clear Floor Space Slope (%) | 4.9 | N/A | B 2 Clear Floor Space Slope (%) | N/A | |

Possible Solutions: Replace Signal Push Button With APS Button. Remove and Replace Clear Space.
