# Access Compliance Report Public Rights-of-Way (Pedestrian Signals)

Main Street: **BRADBURY\_RD** Cross Street: **LOS\_ALAMITOS\_BLV** Location: **NW**

ADA ID: **SGRK211221112406** Signal Type: **One Push Button-Non APS** Overall Compliance: **No** Severity Scores: **BTN 1: 35** **BTN 2: N/A** **No BTN: N/A**

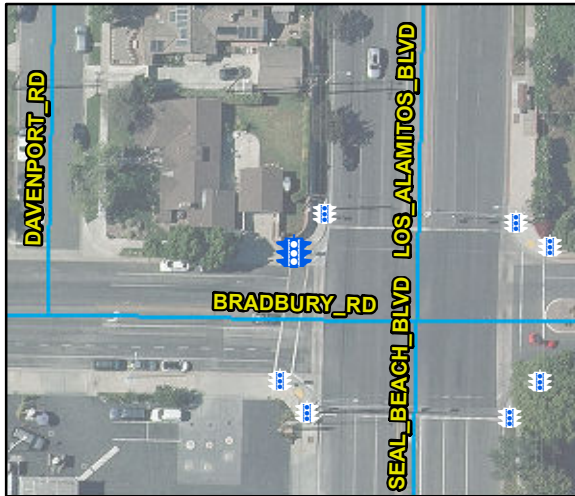
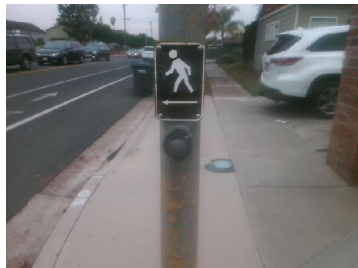
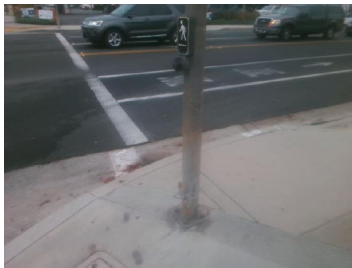
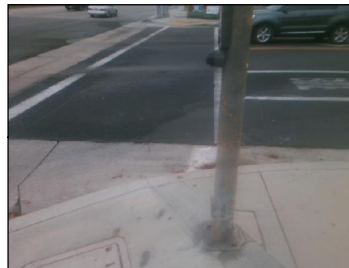
| Compliance | Description | Data | Compliance | Description | Data |
|---|---|---|---|---|---|
| <b>No</b> | B 1 Clear Floor Space XSlope (%) | <b>4</b> | <b>N/A</b> | B 2 Clear Floor Space XSlope (%) | <b>N/A</b> |

Possible Solutions: Replace Signal Push Button With APS Button. Remove and Replace Clear Space.

OC Std/PROW: **R404.2, MUTCD 4e.08**
