# Access Compliance Report Public Rights-of-Way (Pedestrian Signals)

Main Street: **N\_MEADS\_AVE** Cross Street: **N\_MEADS\_AVE** Location: **SE**

ADA ID: **SGRK211222124109** Signal Type: **One Push Button-Non APS** Overall Compliance: **No** Severity Scores: **BTN 1: 30** **BTN 2: N/A** **No BTN: N/A**

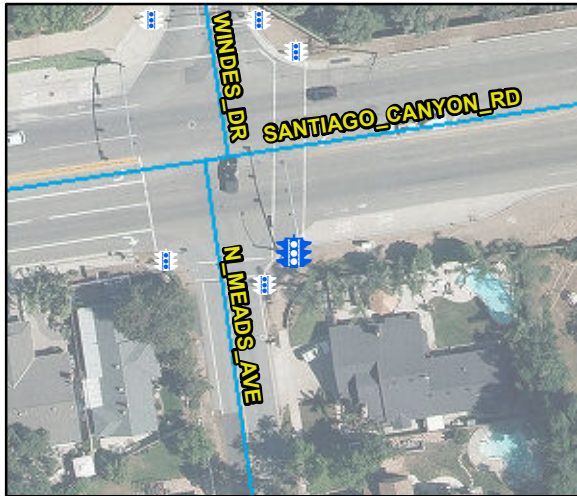
| <b>No</b> B 1 Pilot Light? | <b>No</b> | <b>N/A</b> B 2 Pilot Light? | <b>N/A</b> |

Possible Solutions: Replace Signal Push Button With APS Button. Provide PAR As Indicated.

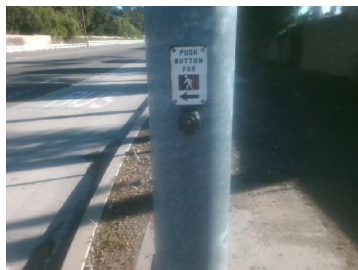
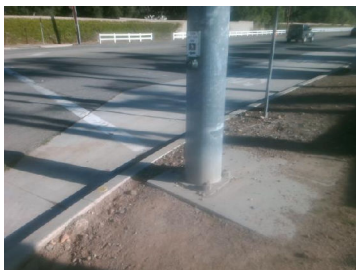
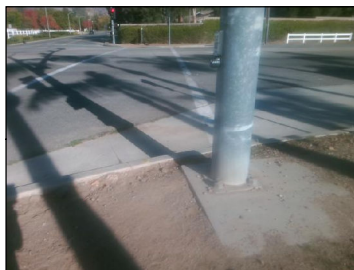
| Compliance | Description | Data | Compliance | Description | Data |
|---|---|---|---|---|---|
| <b>No</b> B 1 Height (in) | | <b>51</b> | <b>N/A</b> | B 2 Height (in) | <b>N/A</b> |
| <b>No</b> B 1 Closed Fist Operation? | | <b>No</b> | <b>N/A</b> | B 2 Closed Fist Operation? | <b>N/A</b> |
| <b>No</b> B 1 Diameter (in) | | <b>0.25</b> | <b>N/A</b> | B 2 Diameter (in) | <b>N/A</b> |
