# Access Compliance Report Public Rights-of-Way (Pedestrian Signals)

Main Street: **N\_MEADS\_AVE** Cross Street: **N\_MEADS\_AVE** Location: **NW**

ADA ID: **SGRK211222125513** Signal Type: **One Push Button-Non APS** Overall Compliance: **No** Severity Scores: **BTN 1: 30** **BTN 2: N/A** **No BTN: N/A**

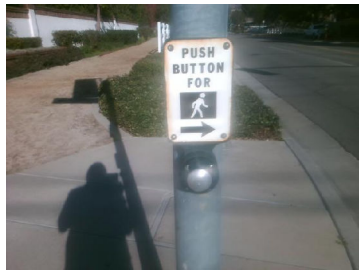
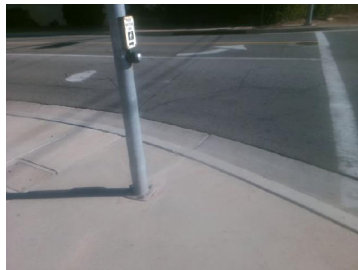
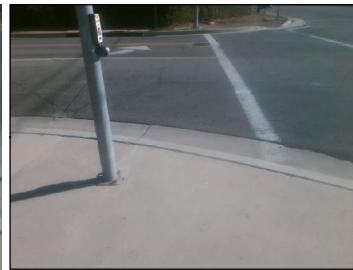
| <b>No</b> B 1 Pilot Light? | <b>No</b> | <b>N/A</b> B 2 Pilot Light? | <b>N/A</b> |

| Compliance | Description | Data | Compliance | Description | Data |
|---|---|---|---|---|---|
| <b>No</b> B 1 Height (in) | | <b>49</b> | <b>N/A</b> | B 2 Height (in) | <b>N/A</b> |

**Possible Solutions: Replace Signal Push Button With APS Button. Adjust Signal Button Height.**

**OC Std/PROW: R406, MUTCD 4e.08**

Total Cost: **\$ 1400**
