# Access Compliance Report Public Rights-of-Way (Pedestrian Signals)

Main Street: **ORANGE\_PARK\_BLV** Cross Street: **ORANGE\_PARK\_BLV** Location: **SW**

ADA ID: **SGRK211222133137** Signal Type: **One Push Button-Non APS** Overall Compliance: **No** Severity Scores: **BTN 1: 10** **BTN 2: N/A** **No BTN: N/A**

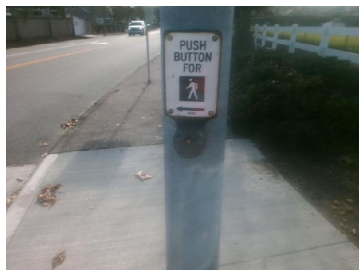
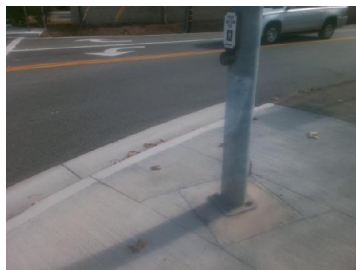
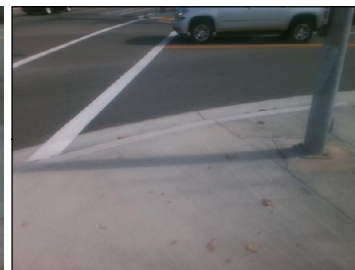
| Compliance | Description | Data | Compliance | Description | Data |
|---|---|---|---|---|---|
| <b>No</b> B 1 Closed Fist Operation? | | <b>No</b> | <b>N/A</b> | B 2 Closed Fist Operation? | <b>N/A</b> |
| <b>No</b> B 1 Diameter (in) | | <b>0.25</b> | <b>N/A</b> | B 2 Diameter (in) | <b>N/A</b> |
| <b>No</b> B 1 DistanceTo XWalk (in) | | <b>120</b> | <b>N/A</b> | B 2 DistanceTo XWalk (in) | <b>N/A</b> |

Possible Solutions: Replace Signal Push Button With APS Button. Remove & Relocate Sign.

Total Cost: \$ **650**
