# Access Compliance Report Public Rights-of-Way (Pedestrian Signals)

Main Street: HEWES\_ST Cross Street: VILLA\_PARK\_RD Location: SW

ADA ID: SGRK211222140130 Signal Type: One Push Button-Non APS Overall Compliance: No Severity Scores: BTN 1: 35 BTN 2: N/A No BTN: N/A

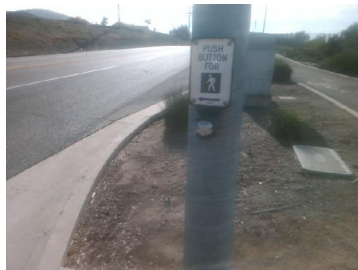
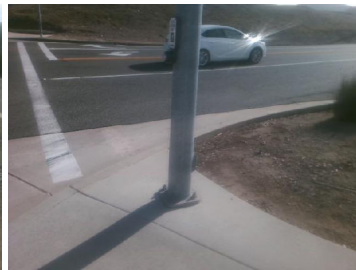
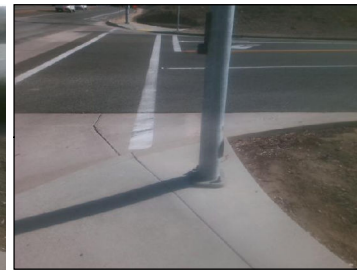
| No B 1 Pilot Light? | No | N/A B 2 Pilot Light? | N/A |

| Compliance | Description | Data | Compliance | Description | Data |
|---|---|---|---|---|---|
| No B 1 Clear Floor Space XSlope (%) | 4.7 | N/A | B 2 Clear Floor Space XSlope (%) | N/A | |

Possible Solutions: Replace Signal Push Button With APS Button. Remove and Replace Clear Space.
