# Access Compliance Report Public Rights-of-Way (Pedestrian Signals)

Main Street: HEWES\_ST Cross Street: VILLA\_PARK\_RD Location: SW

ADA ID: SGRK211222140254 Signal Type: One Push Button-Non APS Overall Compliance: No Severity Scores: BTN 1: 35 BTN 2: N/A No BTN: N/A

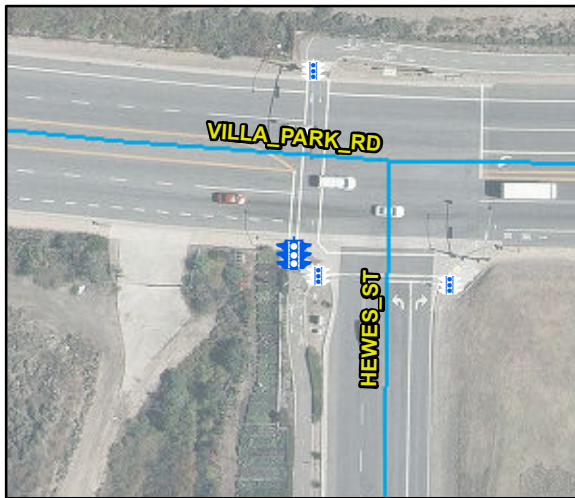
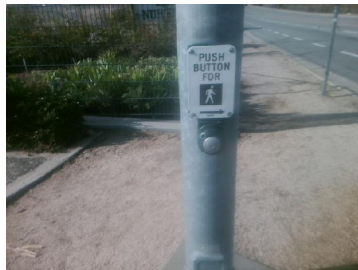
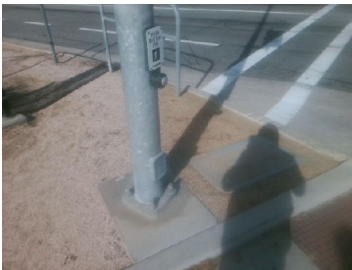
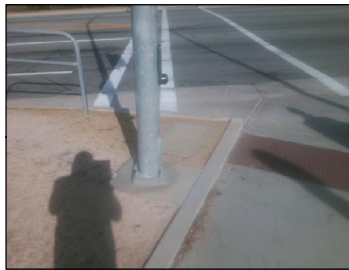
| Compliance | Description | Data | Compliance | Description | Data |
|---|---|---|---|---|---|
| No B 1 Clear Floor Space Slope (%) | 2.8 | N/A | B 2 Clear Floor Space Slope (%) | N/A | |
| No B 1 Clear Floor Space XSlope (%) | 2.4 | N/A | B 2 Clear Floor Space XSlope (%) | N/A | |

Possible Solutions: Replace Signal Push Button With APS Button. Remove and Replace Clear Space.

OC Std/PROW: R404.2, R404.3, MUTCD 4e.08
