# Access Compliance Report Public Rights-of-Way (Pedestrian Signals)

Main Street: **VILLA\_PARK\_RD** Cross Street: **VILLA\_PARK\_RD** Location: **NW**

ADA ID: **SGRK211222140737** Signal Type: **One Push Button-Non APS** Overall Compliance: **No** Severity Scores: **BTN 1: 60** **BTN 2: N/A** **No BTN: N/A**

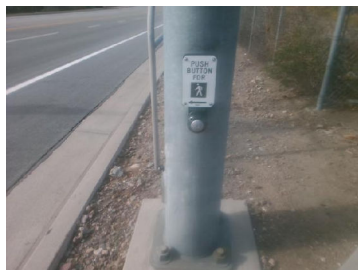
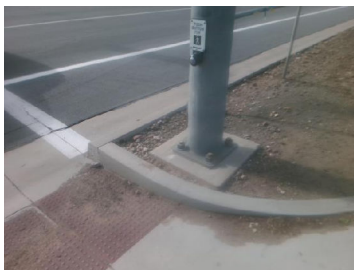
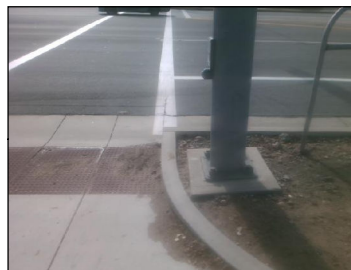
| Compliance | Description | Data | Compliance | Description | Data |
|---|---|---|---|---|---|
| <b>No</b> | B 1 PARA Approach Reach (in) | <b>17</b> | <b>N/A</b> | B 2 PARA Approach Reach (in) | <b>N/A</b> |
| <b>No</b> | B 1 Clear Floor Space Slope (%) | <b>7.8</b> | <b>N/A</b> | B 2 Clear Floor Space Slope (%) | <b>N/A</b> |
| <b>No</b> | B 1 Clear Floor Space XSlope (%) | <b>5.8</b> | <b>N/A</b> | B 2 Clear Floor Space XSlope (%) | <b>N/A</b> |

**Possible Solutions: Replace Signal Push Button With APS Button. Provide Push Button Extension. Remove and Replace Clear Space.**

**OC Std/PROW: R404.2, R404.3, R404.7.1, R404.7.3, MUTCD 4e.08**
