# Access Compliance Report Public Rights-of-Way (Pedestrian Signals)

Main Street: RANCHO\_SANTIAGO\_BLV Cross Street: CHAPMAN\_AVE Location: S

ADA ID: SGRK211223130158 Signal Type: Two Push Buttons-Non APS Overall Compliance: No Severity Scores: BTN 1: 35 BTN 2: 35 No BTN: N/A

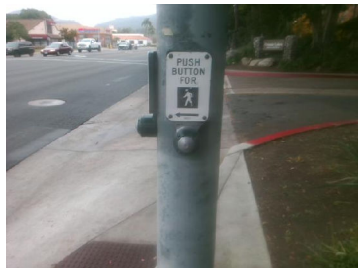
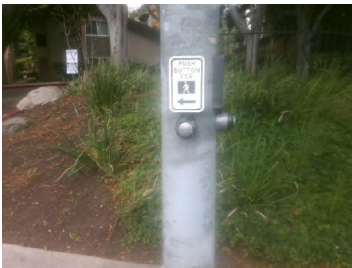
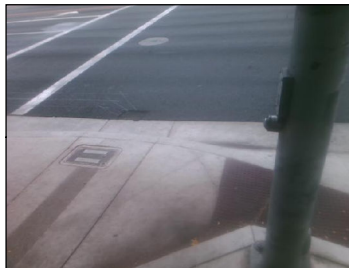
| Compliance | Description | Data | Compliance | Description | Data |
|---|---|---|---|---|---|
| No | B 1 Clear Floor Space Slope (%) | 3.9 | Yes | B 2 Clear Floor Space Slope (%) | 2 |
| No | B 1 Clear Floor Space XSlope (%) | 3.3 | No | B 2 Clear Floor Space XSlope (%) | 2.2 |
| No | B 1 DistanceTo XWalk (in) | 144 | Yes | B 2 DistanceTo XWalk (in) | 0 |

Possible Solutions: Replace Signal Push Button With APS Button. Remove & Relocate Sign. Remove and Replace Clear Space.
