# Access Compliance Report Public Rights-of-Way (Pedestrian Signals)

Main Street: **RANCHO\_SANTIAGO\_BVLD** Cross Street: **E\_CHAPMAN\_AVE** Location: **S**

ADA ID: **SGRK211223130511** Signal Type: **Two Push Buttons-Non APS** Overall Compliance: **No** Severity Scores: **BTN 1: 35** **BTN 2: 35** **No BTN: N/A**

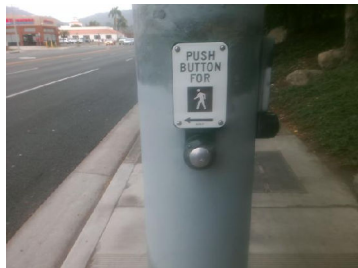
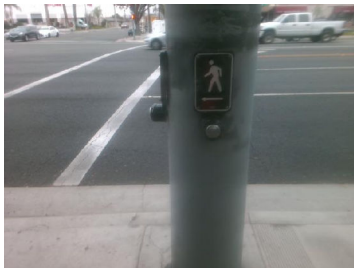
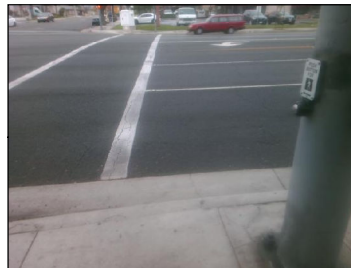
| Compliance | Description | Data | Compliance | Description | Data |
|---|---|---|---|---|---|
| <b>No</b> | B 1 Clear Floor Space XSlope (%) | <b>5.3</b> | <b>No</b> | B 2 Clear Floor Space XSlope (%) | <b>4.1</b> |
| <b>No</b> | B 1 DistanceTo XWalk (in) | <b>64</b> | <b>Yes</b> | B 2 DistanceTo XWalk (in) | <b>0</b> |

**Possible Solutions: Replace Signal Push Button With APS Button. Remove & Relocate Sign. Remove and Replace Clear Space.**
