# Access Compliance Report Public Rights-of-Way (Pedestrian Signals)

Main Street: **CHAPMAN\_AVE** Cross Street: **CANNON\_ST** Location: **NW**

ADA ID: **SGRK220103111313** Signal Type: **One Push Button-Non APS** Overall Compliance: **No** Severity Scores: **BTN 1: 35** **BTN 2: N/A** **No BTN: N/A**

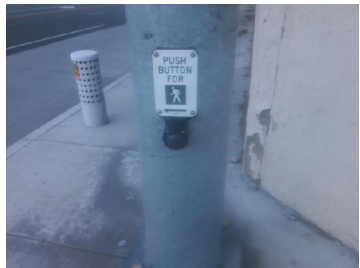
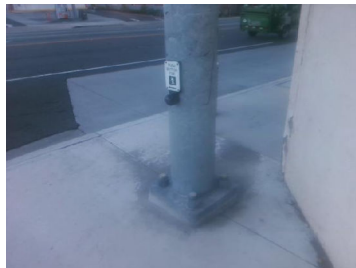
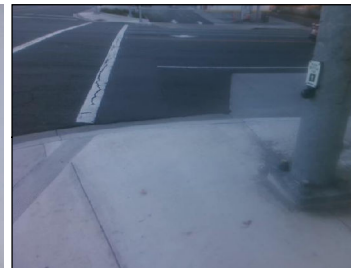
| Compliance | Description | Data | Compliance | Description | Data |
|---|---|---|---|---|---|
| <b>No</b> | B 1 Clear Floor Space Slope (%) | <b>2.7</b> | <b>N/A</b> | B 2 Clear Floor Space Slope (%) | <b>N/A</b> |
| <b>No</b> | B 1 Clear Floor Space XSlope (%) | <b>2.3</b> | <b>N/A</b> | B 2 Clear Floor Space XSlope (%) | <b>N/A</b> |
| <b>No</b> | B 1 DistanceTo XWalk (in) | <b>86</b> | <b>N/A</b> | B 2 DistanceTo XWalk (in) | <b>N/A</b> |
| <b>No</b> | B 1 DistanceTo Curb (in) | <b>83</b> | <b>N/A</b> | B 2 DistanceTo Curb (in) | <b>N/A</b> |

Possible Solutions: Replace Signal Push Button With APS Button. Remove & Relocate Sign.
