# Access Compliance Report Public Rights-of-Way (Pedestrian Signals)

**Main Street:** IRVINE\_BLV **Cross Street:** TUSTIN\_RANCH\_RD **Location:** S

**ADA ID:** SGRK220103131631 **Signal Type:** One Push Button-APS **Overall Compliance:** No **Severity Scores:** BTN 1: 0 BTN 2: N/A No BTN: N/A

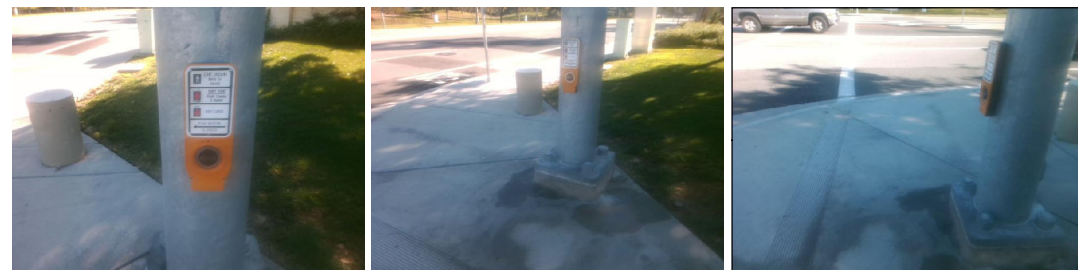
Compliance	Description	Data	Compliance	Description	Data
	Button Count	Button1	Yes	Distant to Additional Button (in)	306
	Additional Button Present?	Yes	N/A	Additional Button ID	SGRK220103131507
	Located In An Island/Median?	No			
N/A	B 1 Sign Present?	Yes	N/A	B 2 Sign Present?	N/A
Yes	B 1 Sign Purpose?	Yes	N/A	B 2 Sign Purpose?	N/A
Yes	B 1 Sign Lettering & Contrast?	Yes	N/A	B 2 Sign Lettering & Contrast?	N/A
Yes	B 1 Parallel To XWalk?	Yes	N/A	B 2 Parallel To XWalk?	N/A
N/A	B 1 PAR to Button?	N/A	N/A	B 2 PAR to Button?	N/A
N/A	B 1 PAR to XWalk?	N/A	N/A	B 2 PAR to XWalk?	N/A
Yes	B 1 Clear Floor Space?	Yes	N/A	B 2 Clear Floor Space?	N/A
N/A	B 1 FWD Approach?	N/A	N/A	B 2 FWD Approach?	N/A
N/A	B 1 FWD Approach Constrained?	N/A	N/A	B 2 FWD Approach Constrained?	N/A
N/A	B 1 FWD Approach Reach (in)	N/A	N/A	B 2 FWD Approach Reach (in)	N/A
N/A	B 1 FWD Approach Width (in)	N/A	N/A	B 2 FWD Approach Width (in)	N/A
N/A	B 1 FWD Approach Obstruction?	N/A	N/A	B 2 FWD Approach Obstruction?	N/A

N/A	B 1 FWD Approach Obstruction Dist (in)	N/A	N/A	B 2 FWD Approach ObstructionDist (in)	N/A
N/A	B 1 PARA Approach?	N/A	N/A	B 2 PARA Approach?	N/A
N/A	B 1 PARA Approach Constrained?	No	N/A	B 2 PARA Approach Constrained?	N/A
Yes	B 1 PARA Approach Reach (in)	0	N/A	B 2 PARA Approach Reach (in)	N/A
N/A	B 1 PARA Approach Width (in)	N/A	N/A	B 2 PARA Approach Width (in)	N/A
N/A	B 1 PARA Approach Obstruction?	No	N/A	B 2 PARA Approach Obstruction?	N/A
N/A	B 1 PARA Approach Obstruction Dist (in)	N/A	N/A	B 2 PARA Approach Obstruction Dist (in)	N/A
Yes	B 1 Clear Floor Space Slope (%)	1.3	N/A	B 2 Clear Floor Space Slope (%)	N/A
Yes	B 1 Clear Floor Space XSlope (%)	1.2	N/A	B 2 Clear Floor Space XSlope (%)	N/A
N/A	B 1 PAR Slope (%)	0.5	N/A	B 2 PAR Slope (%)	N/A
Yes	B 1 Height (in)	38	N/A	B 2 Height (in)	N/A
Yes	B 1 Pressure (#)	5	N/A	B 2 Pressure (#)	N/A
Yes	B 1 Closed Fist Operation?	Yes	N/A	B 2 Closed Fist Operation?	N/A

Yes	B 1 Diameter (in)	2	N/A	B 2 Diameter (in)	N/A
N/A	B 1 Crossing Direction	NE	N/A	B 2 Crossing Direction	N/A
Yes	B 1 DistanceTo XWalk (in)	60	N/A	B 2 DistanceTo XWalk (in)	N/A
No	B 1 DistanceTo Curb (in)	126	N/A	B 2 DistanceTo Curb (in)	N/A
	Parcel Identification Number	500-341-75			
	Google Street View Link

**Possible Solutions:** Replace Signal Push Button With APS Button. Remove & Relocate Sign.
