Access Compliance Report Public Rights-of-Way (Pedestrian Signals)

Main Street: IRVINE_BLV **Cross Street:** TUSTIN_RANCH_RD **Location:** E

ADA ID: SGRK220103132146 **Signal Type:** One Push Button-APS **Overall Compliance:** Yes **Severity Scores:** BTN 1: 0 BTN 2: N/A No BTN: N/A

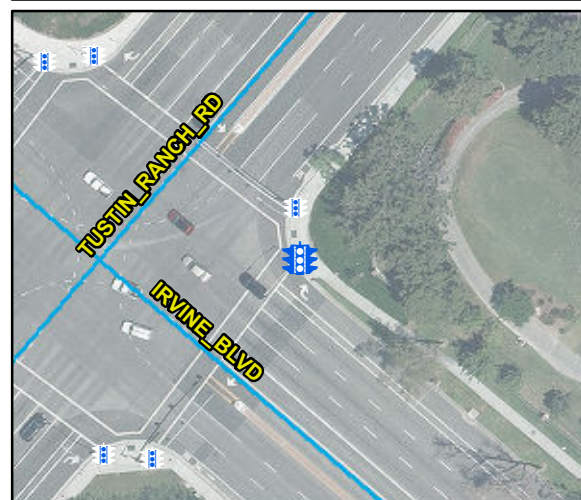
Compliance	Description	Data	Compliance	Description	Data
	Button Count	Button1	Yes	Distant to Additional Button (in)	314
	Additional Button Present?	Yes	N/A	Additional Button ID	SGRK220103132314
	Located In An Island/Median?	No			
N/A	B 1 Sign Present?	Yes	N/A	B 2 Sign Present?	N/A
Yes	B 1 Sign Purpose?	Yes	N/A	B 2 Sign Purpose?	N/A
Yes	B 1 Sign Lettering & Contrast?	Yes	N/A	B 2 Sign Lettering & Contrast?	N/A
Yes	B 1 Parallel To XWalk?	Yes	N/A	B 2 Parallel To XWalk?	N/A
N/A	B 1 PAR to Button?	N/A	N/A	B 2 PAR to Button?	N/A
N/A	B 1 PAR to XWalk?	N/A	N/A	B 2 PAR to XWalk?	N/A
Yes	B 1 Clear Floor Space?	Yes	N/A	B 2 Clear Floor Space?	N/A
N/A	B 1 FWD Approach?	N/A	N/A	B 2 FWD Approach?	N/A
N/A	B 1 FWD Approach Constrained?	N/A	N/A	B 2 FWD Approach Constrained?	N/A
N/A	B 1 FWD Approach Reach (in)	N/A	N/A	B 2 FWD Approach Reach (in)	N/A
N/A	B 1 FWD Approach Width (in)	N/A	N/A	B 2 FWD Approach Width (in)	N/A
N/A	B 1 FWD Approach Obstruction?	N/A	N/A	B 2 FWD Approach Obstruction?	N/A

N/A	B 1 FWD Approach Obstruction Dist (in)	N/A	N/A	B 2 FWD Approach ObstructionDist (in)	N/A
N/A	B 1 PARA Approach?	N/A	N/A	B 2 PARA Approach?	N/A
N/A	B 1 PARA Approach Constrained?	No	N/A	B 2 PARA Approach Constrained?	N/A
Yes	B 1 PARA Approach Reach (in)	0	N/A	B 2 PARA Approach Reach (in)	N/A
N/A	B 1 PARA Approach Width (in)	N/A	N/A	B 2 PARA Approach Width (in)	N/A
N/A	B 1 PARA Approach Obstruction?	No	N/A	B 2 PARA Approach Obstruction?	N/A
N/A	B 1 PARA Approach Obstruction Dist (in)	N/A	N/A	B 2 PARA Approach Obstruction Dist (in)	N/A
Yes	B 1 Clear Floor Space Slope (%)	0.9	N/A	B 2 Clear Floor Space Slope (%)	N/A
Yes	B 1 Clear Floor Space XSlope (%)	0.2	N/A	B 2 Clear Floor Space XSlope (%)	N/A
N/A	B 1 PAR Slope (%)	1	N/A	B 2 PAR Slope (%)	N/A
Yes	B 1 Height (in)	40	N/A	B 2 Height (in)	N/A
Yes	B 1 Pressure (#)	5	N/A	B 2 Pressure (#)	N/A
Yes	B 1 Closed Fist Operation?	Yes	N/A	B 2 Closed Fist Operation?	N/A

Yes	B 1 Diameter (in)	2	N/A	B 2 Diameter (in)	N/A
N/A	B 1 Crossing Direction	SW	N/A	B 2 Crossing Direction	N/A
Yes	B 1 DistanceTo XWalk (in)	18	N/A	B 2 DistanceTo XWalk (in)	N/A
Yes	B 1 DistanceTo Curb (in)	36	N/A	B 2 DistanceTo Curb (in)	N/A
	Parcel Identification Number	501-104-08			
	Google Street View Link

N/A	Is Button 1 APS or Non-APS?	APS	N/A	Is Button 2 APS or Non-APS?	N/A
N/A	B 1 VibroTact Arrow?	Yes	N/A	B 2 VibroTact Arrow?	N/A
Yes	B 1 VibroTact Parallel to Xing?	Yes	N/A	B 2 VibroTact Parallel to Xing?	N/A
N/A	B 1 VibroTact Contrast	Yes	N/A	B 2 VibroTact Contrast	N/A
Yes	B 1 Pilot Light?	Yes	N/A	B 2 Pilot Light?	N/A
Yes	B 1 Pilot Light Illumination?	Yes	N/A	B 2 Pilot Light Illumination?	N/A
N/A	B 1 Walk Indicator Type	VerbalMessage	N/A	B 2 Walk Indicator Type	N/A
N/A	B 1 Walk Indicator Audible?	Yes	N/A	B 2 Walk Indicator Audible?	N/A
N/A	B 1 Locator Tone?	Yes	N/A	B 2 Locator Tone?	N/A
N/A	B 1 Tone Audible Range?	Yes	N/A	B 2 Tone Audible Range?	N/A
	B 1 Addl APS Features?	No		B 2 Addl APS Features?	N/A
	B 1 Addl APS Features Notes	N/A		B 2 Addl APS Features Notes	N/A

Possible Solutions: N/A
