# Access Compliance Report Public Rights-of-Way (Pedestrian Signals)

Main Street: 17TH\_ST Cross Street: PROSPECT\_AVE Location: SW

ADA ID: SGRK220124103338 Signal Type: One Push Button-Non APS Overall Compliance: No Severity Scores: BTN 1: 35 BTN 2: N/A No BTN: N/A

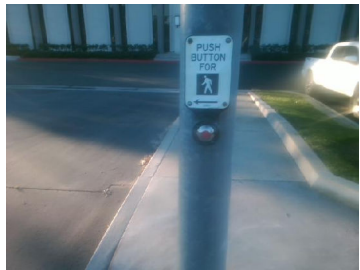
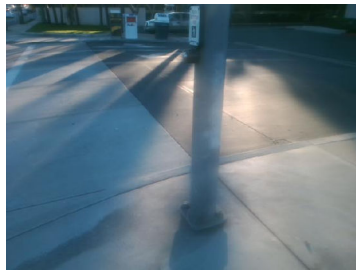
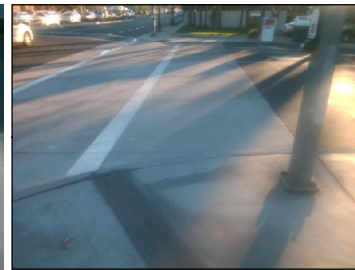
| Compliance | Description | Data | Compliance | Description | Data |
|---|---|---|---|---|---|
| No | B 1 Clear Floor Space XSlope (%) | 2.7 | N/A | B 2 Clear Floor Space XSlope (%) | N/A |
| No | B 1 DistanceTo XWalk (in) | 96 | N/A | B 2 DistanceTo XWalk (in) | N/A |

| No | B 1 Pilot Light? | No | N/A | B 2 Pilot Light? | N/A |

Possible Solutions: Replace Signal Push Button With APS Button. Remove & Relocate Sign.

Total Cost: \$ 650
