# Access Compliance Report

## Public Rights-of-Way

Main Street: PROSPECT\_AVE Cross Street: 17TH\_ST Location: SW

ADA ID: SGRK220124103450 Signal Type: One Push Button-Non APS Overall Compliance: No Severity Scores: BTN 1: 10 BTN 2: N/A No BTN: N/A

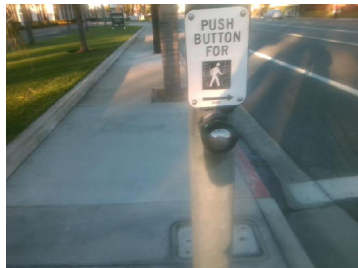
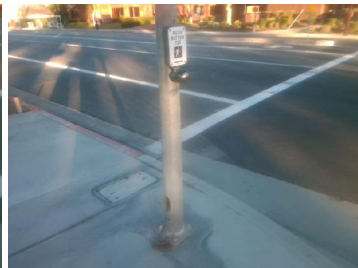
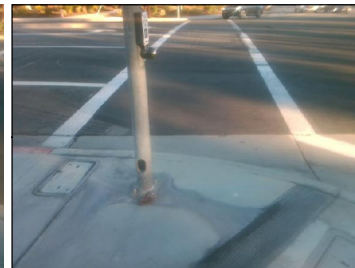
| No B 1 Pilot Light? | No | N/A B 2 Pilot Light? | N/A |

Possible Solutions: Replace Signal Push Button With APS Button.

OC Std/PROW: MUTCD 4e.08

Total Cost: \$ 900
