# Access Compliance Report Public Rights-of-Way (Pedestrian Signals)

Main Street: FAIRHAVEN\_AVE Cross Street: YORBA\_ST Location: NW

ADA ID: SGRK220126122538 Signal Type: One Push Button-Non APS Overall Compliance: No Severity Scores: BTN 1: 10 BTN 2: N/A No BTN: N/A

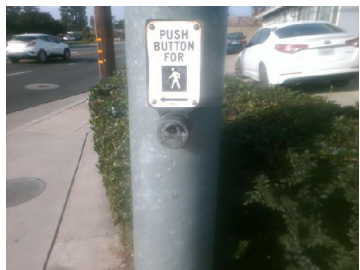
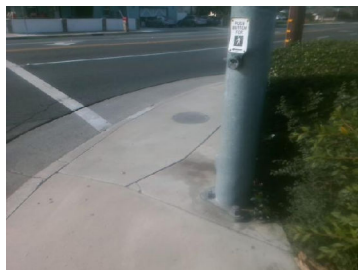
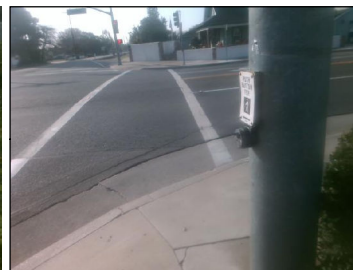
| Compliance | Description | Data | Compliance | Description | Data |
|---|---|---|---|---|---|
| No B 1 Closed Fist Operation? | | No | N/A | B 2 Closed Fist Operation? | N/A |
| No B 1 Diameter (in) | | 0.25 | N/A | B 2 Diameter (in) | N/A |
| No B 1 DistanceTo Curb (in) | | 84 | N/A | B 2 DistanceTo Curb (in) | N/A |

Possible Solutions: Replace Signal Push Button With APS Button. Remove & Relocate Sign.
