# Access Compliance Report Public Rights-of-Way (Pedestrian Signals)

Main Street: **YORBA\_ST** Cross Street: **FAIRHAVEN\_AVE** Location: **SW**

ADA ID: **SGRK220126122910** Signal Type: **One Push Button-Non APS** Overall Compliance: **No** Severity Scores: **BTN 1: 55** **BTN 2: N/A** **No BTN: N/A**

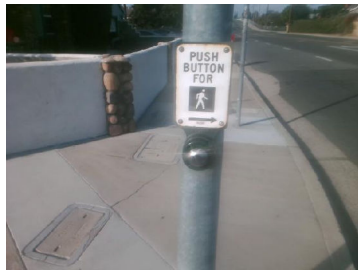
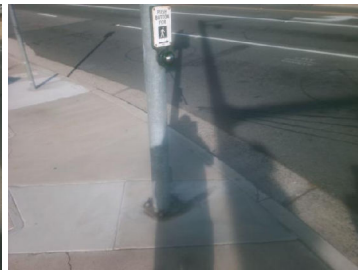
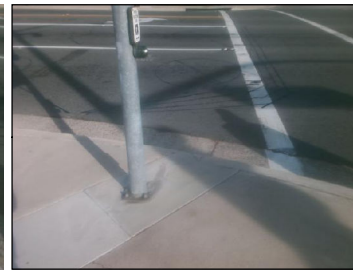
| <b>No</b> B 1 Pilot Light? | <b>No</b> | <b>N/A</b> B 2 Pilot Light? | <b>N/A</b> |

| Compliance | Description | Data | Compliance | Description | Data |
|---|---|---|---|---|---|
| <b>No</b> B 1 Clear Floor Space Slope (%) | | <b>5.3</b> | <b>N/A</b> | B 2 Clear Floor Space Slope (%) | <b>N/A</b> |
| <b>No</b> B 1 Height (in) | | <b>56</b> | <b>N/A</b> | B 2 Height (in) | <b>N/A</b> |

**Possible Solutions: Replace Signal Push Button With APS Button. Adjust Signal Button Height. Remove and Replace Clear Space.**
