# Access Compliance Report

## Public Rights-of-Way

Main Street: YORBA\_ST Cross Street: FAIRHAVEN\_AVE Location: SW

ADA ID: SGRK220126123025 Signal Type: One Push Button-Non APS Overall Compliance: No Severity Scores: BTN 1: 35 BTN 2: N/A No BTN: N/A

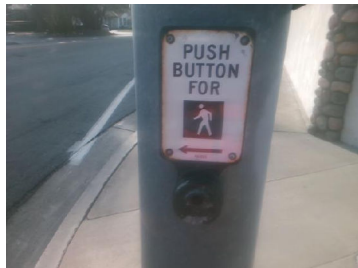
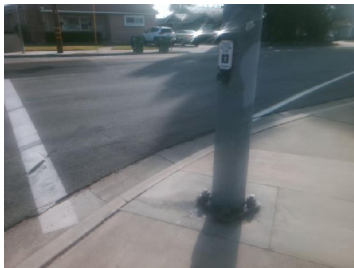
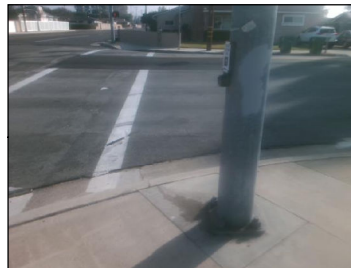
| Compliance | Description | Data | Compliance | Description | Data |
|---|---|---|---|---|---|
| No B 1 Clear Floor Space XSlope (%) | | 2.2 | N/A | B 2 Clear Floor Space XSlope (%) | N/A |
| No B 1 Closed Fist Operation? | | No | N/A | B 2 Closed Fist Operation? | N/A |
| No B 1 Diameter (in) | | 0.25 | N/A | B 2 Diameter (in) | N/A |

Possible Solutions: Replace Signal Push Button With APS Button. Remove and Replace Clear Space.

OC Std/PROW: R404.2, DMS-11132, R104.2, R209.1, MUTCD 4e.08
