# Access Compliance Report Public Rights-of-Way (Pedestrian Signals)

Main Street: FAIRHAVEN\_AVE Cross Street: YORBA\_ST Location: SE

ADA ID: SGRK220126123334 Signal Type: One Push Button-Non APS Overall Compliance: No Severity Scores: BTN 1: 10 BTN 2: N/A No BTN: N/A

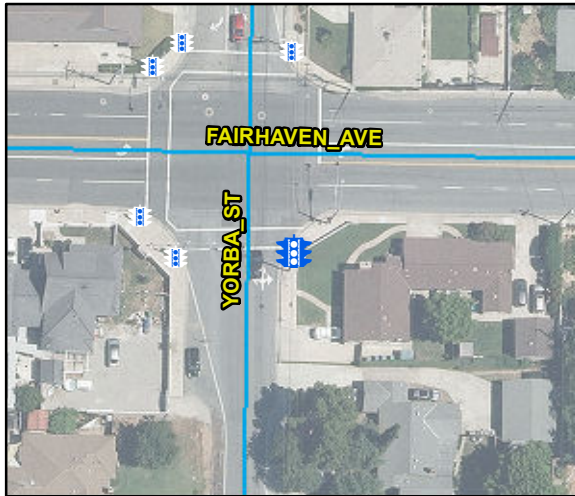
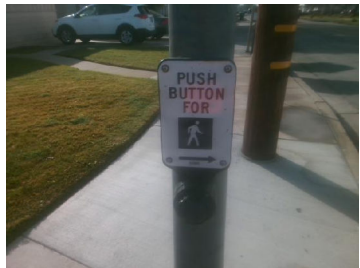
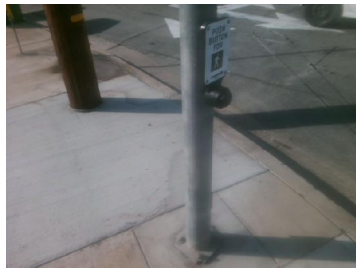
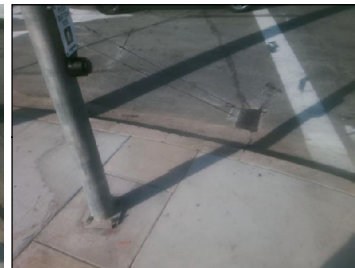
| No B 1 Pilot Light? | No | N/A B 2 Pilot Light? | N/A |

| Compliance | Description | Data | Compliance | Description | Data |
|---|---|---|---|---|---|
| No | B 1 DistanceTo XWalk (in) | 67 | N/A | B 2 DistanceTo XWalk (in) | N/A |

Possible Solutions: Replace Signal Push Button With APS Button. Remove & Relocate Sign.

OC Std/PROW: MUTCD 4e.08

Total Cost: \$ 650
