# Access Compliance Report Public Rights-of-Way (Pedestrian Signals)

Main Street: **E\_YORBA\_LINDA\_BLV** Cross Street: **MCCORMACK\_LN** Location: **NW**

ADA ID: **SGRK220201133510** Signal Type: **One Push Button-Non APS** Overall Compliance: **No** Severity Scores: **BTN 1: 35** **BTN 2: N/A** **No BTN: N/A**

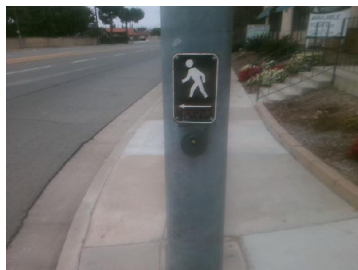
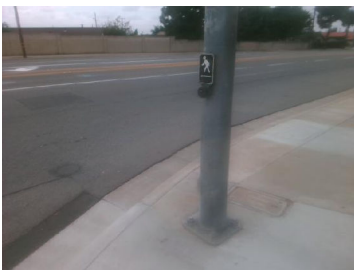
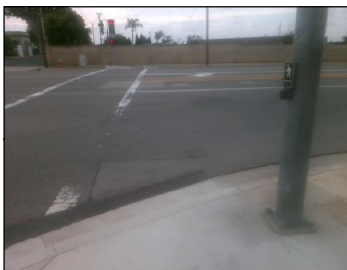
| Compliance | Description | Data | Compliance | Description | Data |
|---|---|---|---|---|---|
| <b>No</b> B 1 Clear Floor Space Slope (%) | | <b>3.9</b> | <b>N/A</b> | B 2 Clear Floor Space Slope (%) | <b>N/A</b> |
| <b>No</b> B 1 Closed Fist Operation? | | <b>No</b> | <b>N/A</b> | B 2 Closed Fist Operation? | <b>N/A</b> |
| <b>No</b> B 1 Diameter (in) | | <b>0.25</b> | <b>N/A</b> | B 2 Diameter (in) | <b>N/A</b> |
| <b>No</b> B 1 DistanceTo XWalk (in) | | <b>86</b> | <b>N/A</b> | B 2 DistanceTo XWalk (in) | <b>N/A</b> |

Possible Solutions: Replace Signal Push Button With APS Button. Remove & Relocate Sign.
