# Access Compliance Report Public Rights-of-Way (Pedestrian Signals)

Main Street: DANA\_POINT\_HARBOR\_DR Cross Street: PUERTO\_PL Location: SE

ADA ID: SGRK220208150317 Signal Type: One Push Button-APS Overall Compliance: No Severity Scores: BTN 1: 0 BTN 2: N/A No BTN: N/A

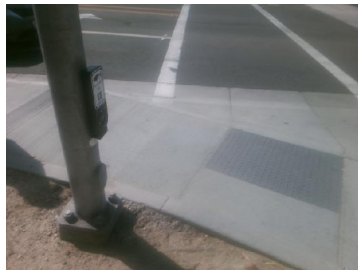
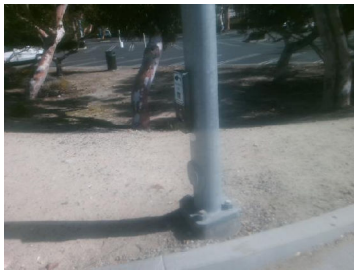
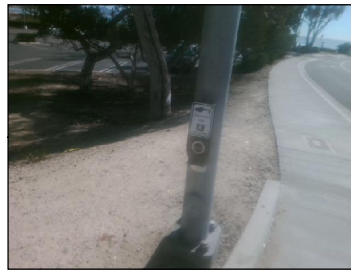
| Compliance | Description | Data | Compliance | Description | Data |
|---|---|---|---|---|---|
| No | B 1 DistanceTo Curb (in) | 80 | N/A | B 2 DistanceTo Curb (in) | N/A |

Possible Solutions: Replace Signal Push Button With APS Button. Remove & Relocate Sign.
