# Access Compliance Report Public Rights-of-Way (Pedestrian Signals)

Main Street: DANA\_POINT\_HARBOR\_DR Cross Street: STREET\_OF\_THE\_GOLDEN\_LANTERN Location: SW

ADA ID: SGRK220208163008 Signal Type: One Push Button-Non APS Overall Compliance: Yes Severity Scores: BTN 1: 0 BTN 2: N/A No BTN: N/A

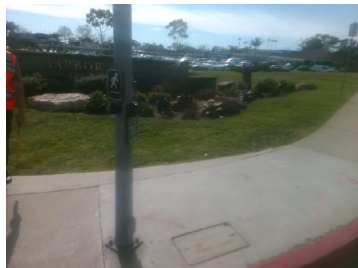
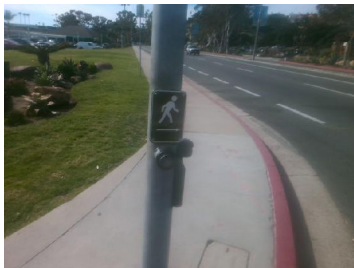
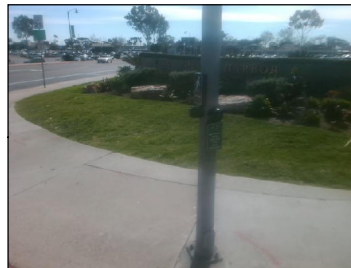
Surveyor Notes: Button 2 for Bike Lane

| Compliance | Description | Data | Compliance | Description | Data |
|---|---|---|---|---|---|
| | Button Count | Button1 | Yes | Distant to Additional Button (in) | 273 |
| Yes | B 1 Clear Floor Space Slope (%) | 0.8 | N/A | B 2 Clear Floor Space Slope (%) | 1.3 |
| Yes | B 1 Clear Floor Space XSlope (%) | 1.1 | N/A | B 2 Clear Floor Space XSlope (%) | 0.8 |
| Yes | B 1 Height (in) | 47 | N/A | B 2 Height (in) | 47 |
| Yes | B 1 Closed Fist Operation? | Yes | N/A | B 2 Closed Fist Operation? | No |
| Yes | B 1 Diameter (in) | 2 | N/A | B 2 Diameter (in) | 5 |
| Yes | B 1 DistanceTo XWalk (in) | 25 | N/A | B 2 DistanceTo XWalk (in) | 15 |
| Yes | B 1 DistanceTo Curb (in) | 27 | N/A | B 2 DistanceTo Curb (in) | 12 |

Possible Solutions: N/A
