# Access Compliance Report Public Rights-of-Way (Pedestrian Signals)

Main Street: DANA\_POINT\_HARBOR\_DR Cross Street: STREET\_OF\_THE\_GOLDEN\_LANTERN Location: NE

ADA ID: SGRK220208164604 Signal Type: One Push Button-Non APS Overall Compliance: No Severity Scores: BTN 1: 55 BTN 2: N/A No BTN: N/A

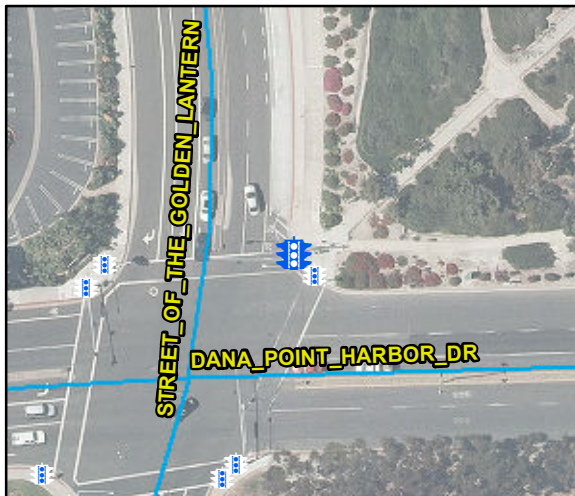
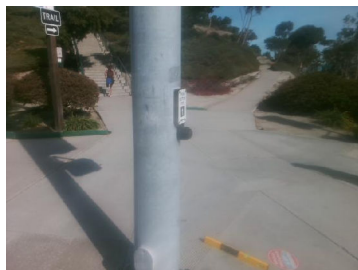
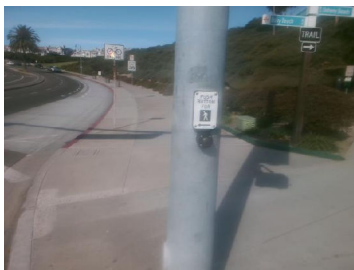
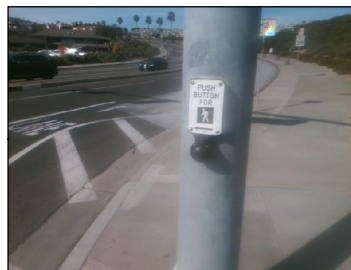
| Compliance | Description | Data | Compliance | Description | Data |
|---|---|---|---|---|---|
| No B 1 Clear Floor Space Slope (%) | 9 | N/A | B 2 Clear Floor Space Slope (%) | N/A | |
| No B 1 Clear Floor Space XSlope (%) | 2.2 | N/A | B 2 Clear Floor Space XSlope (%) | N/A | |
| No B 1 Height (in) | 49 | N/A | B 2 Height (in) | N/A | |

Possible Solutions: Replace Signal Push Button With APS Button. Adjust Signal Button Height. Remove and Replace Clear Space.

OC Std/PROW: R404.2, R404.3, R406, MUTCD 4e.08

Total Cost: \$ 1778
