# Access Compliance Report Public Rights-of-Way (Pedestrian Signals)

Main Street: **DANA\_POINT\_HARBOR\_DR** Cross Street: **CASITAS\_PL** Location: **SE**

ADA ID: **SGRK220208170611** Signal Type: **One Push Button-Non APS** Overall Compliance: **No** Severity Scores: **BTN 1: 35** **BTN 2: N/A** **No BTN: N/A**

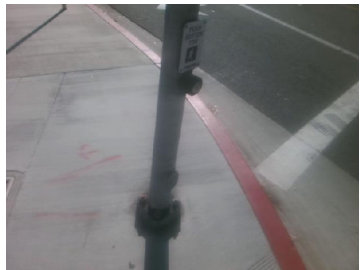
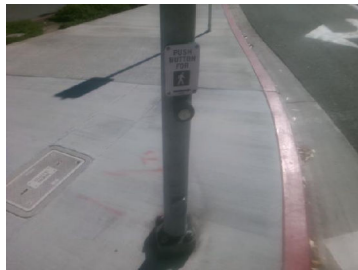
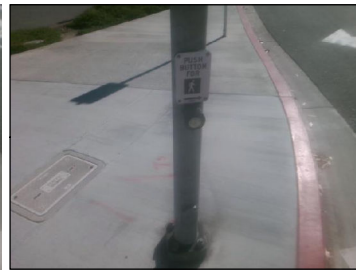
| <b>No</b> B 1 Pilot Light? | <b>No</b> | <b>N/A</b> B 2 Pilot Light? | <b>N/A</b> |

| Compliance | Description | Data | Compliance | Description | Data |
|---|---|---|---|---|---|
| <b>No</b> | B 1 Clear Floor Space XSlope (%) | <b>3.8</b> | <b>N/A</b> | B 2 Clear Floor Space XSlope (%) | <b>N/A</b> |

Possible Solutions: Replace Signal Push Button With APS Button. Remove and Replace Clear Space.

Total Cost: \$ **1278**
