# Access Compliance Report Public Rights-of-Way (Pedestrian Signals)

Main Street: **ORANGE\_AVE** Cross Street: **BROOKHURST\_ST** Location: **NE**

ADA ID: **SGRK220218193800** Signal Type: **One Push Button-Non APS** Overall Compliance: **No** Severity Scores: **BTN 1: 10** **BTN 2: N/A** **No BTN: N/A**

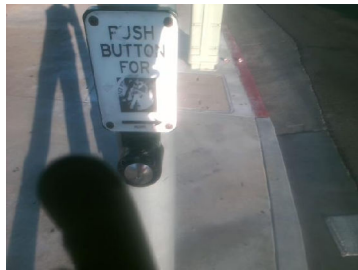
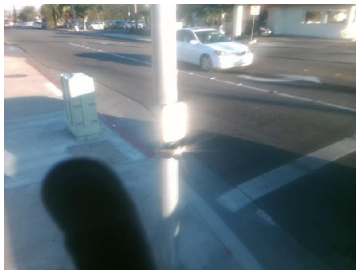
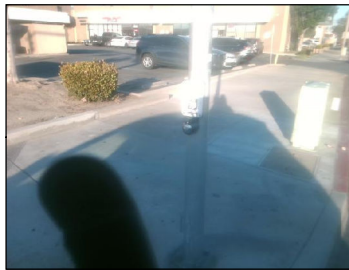
| <b>No</b> B 1 Pilot Light? | <b>No</b> | <b>N/A</b> B 2 Pilot Light? | <b>N/A</b> |

Possible Solutions: Replace Signal Push Button With APS Button. Provide PAR As Indicated.

OC Std/PROW: **R404.3, MUTCD 4e.08**

Total Cost: \$ **1278**
