# Access Compliance Report

## Public Rights-of-Way

### (Pedestrian Signals)

Main Street: **EDINGER\_AVE** Cross Street: **HARBOR\_BLVD** Location: **SW**

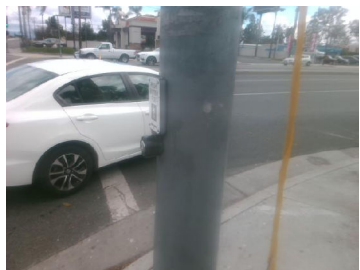
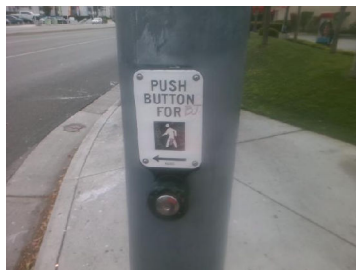
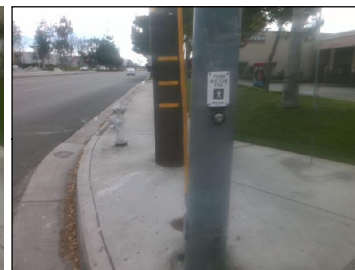
ADA ID: **SGRK220222151356** Signal Type: **One Push Button-Non APS** Overall Compliance: **No** Severity Scores: **BTN 1: 35** **BTN 2: N/A** **No BTN: N/A**

| Compliance | Description | Data | Compliance | Description | Data |
|---|---|---|---|---|---|
| <b>No</b> B 1 Clear Floor Space XSlope (%) | | <b>5.1</b> | <b>N/A</b> | B 2 Clear Floor Space XSlope (%) | <b>N/A</b> |

Possible Solutions: Replace Signal Push Button With APS Button. Remove and Replace Clear Space.
