# Access Compliance Report Public Rights-of-Way (Pedestrian Signals)

Main Street: HARBOR\_BLV Cross Street: EDINGER\_AVE Location: SE

ADA ID: SGRK220222161254 Signal Type: One Push Button-Non APS Overall Compliance: No Severity Scores: BTN 1: 10 BTN 2: N/A No BTN: N/A

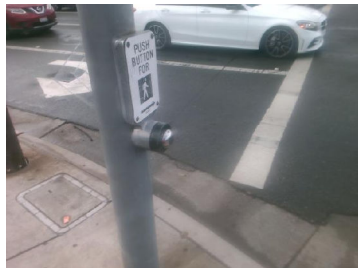
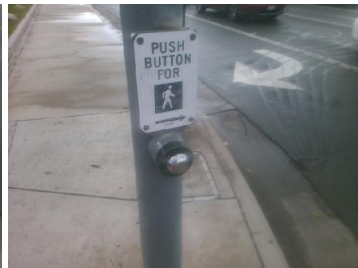
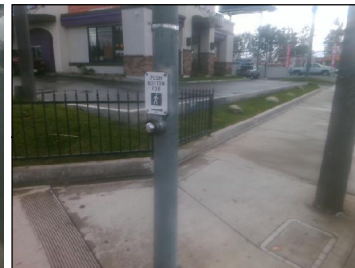
| No B 1 Pilot Light? | No | N/A B 2 Pilot Light? | N/A |

Possible Solutions: Replace Signal Push Button With APS Button.

Total Cost: \$ 900
