# Access Compliance Report Public Rights-of-Way (Pedestrian Signals)

Main Street: **ORANGE\_AVE** Cross Street: **S\_BROOKHURST\_ST** Location: **SE**

ADA ID: **SGRK220224160647** Signal Type: **One Push Button-Non APS** Overall Compliance: **No** Severity Scores: **BTN 1: 35** **BTN 2: N/A** **No BTN: N/A**

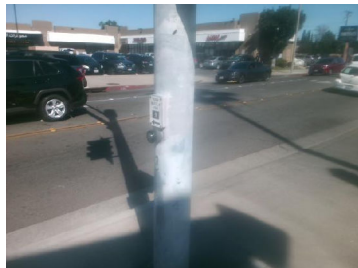
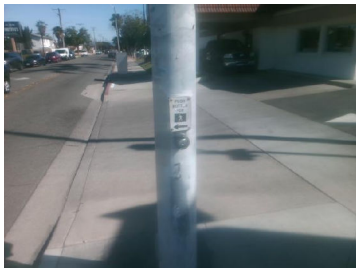
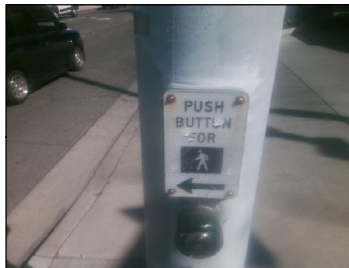
| <b>No</b> B 1 Pilot Light? | <b>No</b> | <b>N/A</b> B 2 Pilot Light? | <b>N/A</b> |

| Compliance | Description | Data | Compliance | Description | Data |
|---|---|---|---|---|---|
| <b>No</b> B 1 Clear Floor Space XSlope (%) | | <b>2.9</b> | <b>N/A</b> | B 2 Clear Floor Space XSlope (%) | <b>N/A</b> |
| <b>No</b> B 1 DistanceTo XWalk (in) | | <b>160</b> | <b>N/A</b> | B 2 DistanceTo XWalk (in) | <b>N/A</b> |

Possible Solutions: Replace Signal Push Button With APS Button. Remove & Relocate Sign.

OC Std/PROW: **MUTCD 4e.08, R404.2**

Total Cost: \$ **650**
