VERTICAL CONTROL DATA SHEET O.C.S. 1995 ADJUSTMENT

Designation: 2C-100-75

City / Location: Yorba Linda

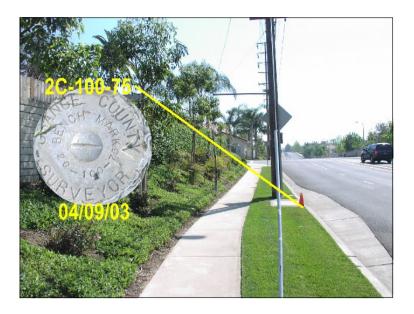
DESCRIBED BY OCS 2003 - FOUND 3 3\4" OCS ALUMINUM BENCHMARK DISK STAMPED "2C-100-75", SET IN THE SOUTHWESTERLY CORNER OF A 4 FT. BY 8 FT. CONCRETE CATCH BASIN. MONUMENT IS LOCATED IN THE NORTHWESTERLY CORNER OF THE INTERSECTION OF BUENA VISTA AVENUE AND JEFFERSON STREET, 155 FT. WESTERLY OF THE CENTERLINE OF JEFFERSON AND 28 .5 FT. NORTHERLY OF THE CENTERLINE OF BUENA VISTA. MONUMENT IS SET LEVEL WITH THE SIDEWALK.
