## Designation: 3D-150-80

City / Location: Live Oak Canyon

Monument Type: Orange County Surveyor's 3 3/4"  
Aluminum Disk

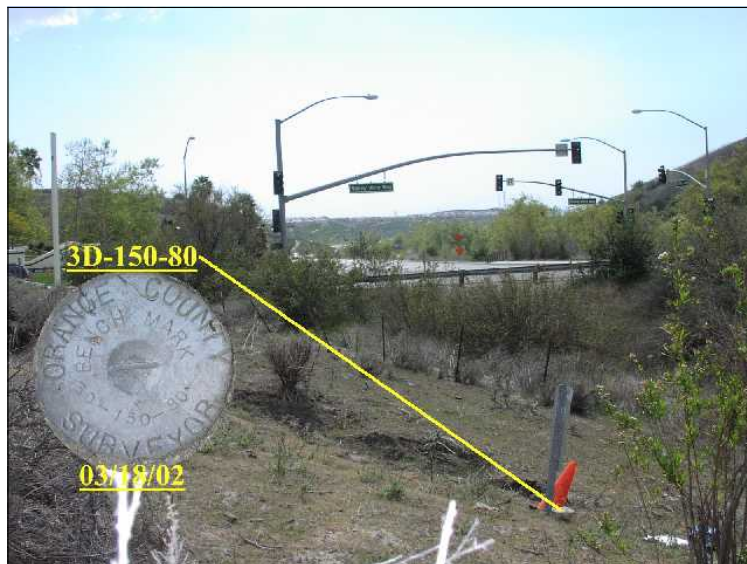
DESCRIBED BY OCS 2002 - FOUND 3 3/4" OCS ALUMINUM BENCHMARK DISK STAMPED "3D-150-80", SET IN THE TOP OF A 6 IN. BY 6 IN. CONCRETE POST. MONUMENT IS LOCATED IN THE NORTHEAST CORNER OF THE INTERSECTION OF EL TORO ROAD AND VALLEY VISTA WAY, 20 FT. EASTERLY OF A 4 FT. HIGH BARBED WIRE FENCE ALONG THE EASTERLY SIDE OF EL TORO ROAD, 175 FT. NORTHERLY OF THE CENTERLINE OF VALLEY VISTA WAY AND 0.7 FT. WESTERLY OF A PADDLE POST. MONUMENT IS SET LEVEL WITH THE GROUND.
