Designation: 3PP-26-89

City / Location: Santa Margarita

Monument Type: Orange County Surveyor's 3 3/4"
Aluminum Disk

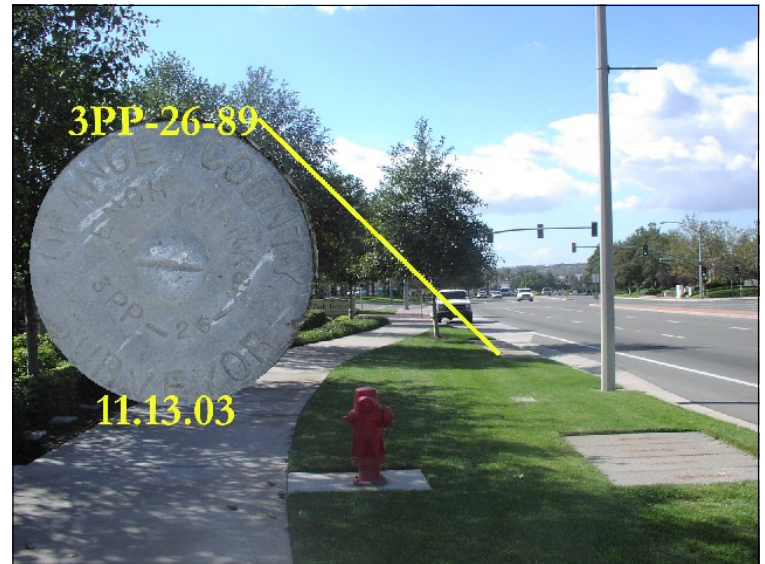
DESCRIBED BY OCS 2003 - FOUND 3 3/4" OCS ALUMINUM BENCHMARK DISK STAMPED "3PP-26-89", SET IN THE SOUTHEASTERLY CORNER OF A 3.5 FT. BY 30 FT. CONCRETE CATCH BASIN. MONUMENT IS LOCATED IN THE SOUTHEASTERLY CORNER OF THE INTERSECTION OF SANTA MARGARITA AND BUENA SUERTE, 52.2 FT. SOUTHERLY OF THE CENTERLINE OF SANTA MARGARITA AND 240 FT. +/- FROM THE CENTERLINE OF BUENA SUERTE. MONUMENT IS SET LEVEL WITH THE SIDEWALK.
