Designation: 3D-150-80

City / Location: Live Oak Canyon

Monument Type: Orange County Surveyor's 3 3/4"
Aluminum Disk

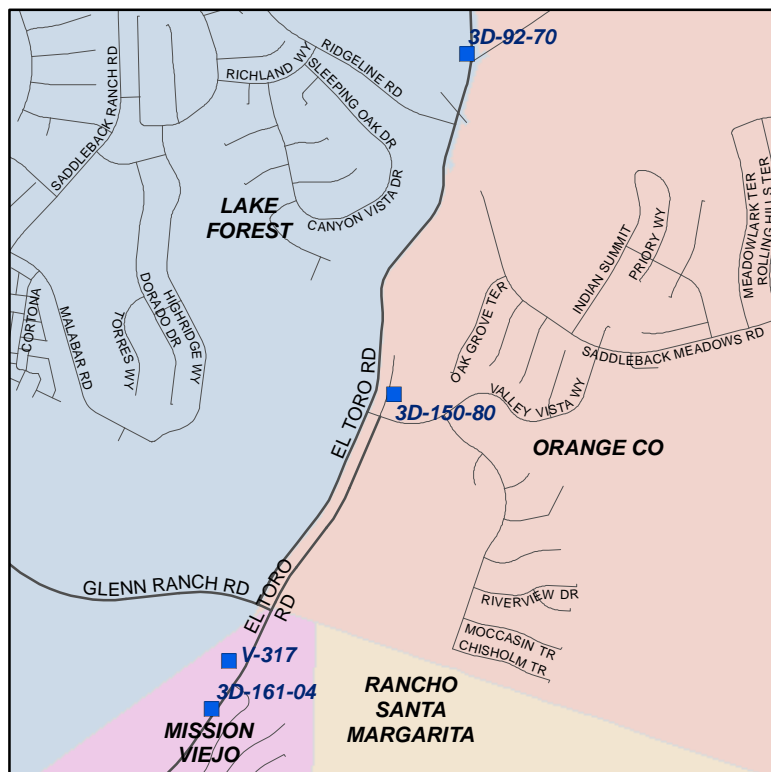
DESCRIBED BY OCS 2002 - FOUND 3 3/4" OCS ALUMINUM BENCHMARK DISK STAMPED "3D-150-80", SET IN THE TOP OF A 6 IN. BY 6 IN. CONCRETE POST. MONUMENT IS LOCATED IN THE NORTHEAST CORNER OF THE INTERSECTION OF EL TORO ROAD AND VALLEY VISTA WAY, 20 FT. EASTERLY OF A 4 FT. HIGH BARBED WIRE FENCE ALONG THE EASTERLY SIDE OF EL TORO ROAD, 175 FT. NORTHERLY OF THE CENTERLINE OF VALLEY VISTA WAY AND 0.7 FT. WESTERLY OF A PADDLE POST. MONUMENT IS SET LEVEL WITH THE GROUND.
