CORNER RECORD	Document Num	Z015-0888B
City ofTUSTIN		
Brief Legal Description GREEN_WILLOW_COURT		
		COORDINATES (Optional)
CORNER TYPE		N
Government Corner ☐ Co	entrol 🔳	N E Zone NAD27 NAD83[
Meander 🗅 Pr	operty 🔲	NAD83 Epoch
Rancho 🗆 Ot	her 🗖	Elevation
Date of Survey 9/15/	2014	Units: Metric□ Imperial□ U.S. Survey
Corner — Left as found □ Found and tagged	☐ Established	☐ Reestablished ■ Rebuilt ☐
Identification and type of corner found; Evidence used to		
Found as described on the reverse of this she	eet.

R-1 = COUNTY OF ORANGE CORNER RECORD 2014-2723 A] = RECORD & MEASURED DISTANCE PER R-1

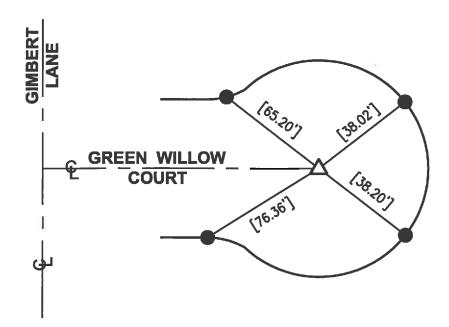
↑ FD NOTHING, SET GEAR SPK & W, STAMPED "LS 5411"" PER TIES ON R-1, FLUSH, AFTER CONSTRUCTION.

FD L, T & T "LS 8294" IN T.C. PER R-1.
